This letter report provides the Northern Sands Wisconsin LLC (NSW) response to the Chippewa County Land Conservation and Forest Management letter of 1 November 2018 that referred to additional requests for information in meeting Permit #2015-01.

Scope of Work

Figure 1 - Study Area & HUC 12 Watersheds
 Phase 1 - Off-Site Seep, Spring, Wetland & Surface Water Assessment
 June, 2019

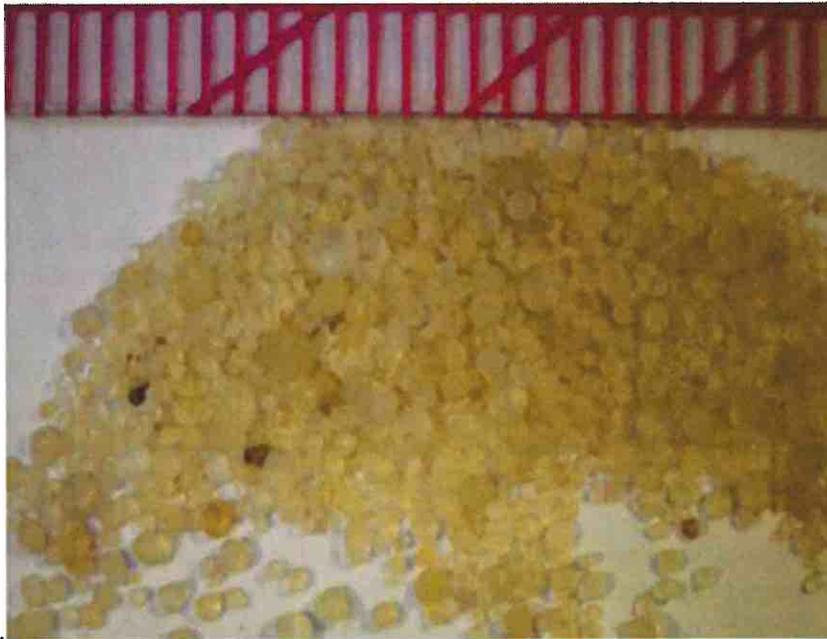
Figure 3: Photomicrograph of coarse grained sand from soil boring HSA 10 (10-11.5'). This sand is characteristic of the Wonewoc Formation and was collected ~17' above the 1100' contour. Similar sand may be sampled to an elevation of -1210-1250', which is the contact between the Wonewoc Formation and overlying Lone Rock Formation. Red scale bar is in millimeters.

Hollow stem auger borings (HAS-8, HAS-9, HAS-10) were completed on 14 May 2019 on the Jensen property (Figure 2; Appendix 1). Soil borings demonstrate that fine to medium grained sand of the Wonewoc Formation occurs above and below the 1100' contour (Figures 2, 3). Two of the soil borings were specifically located to test for the potential of a formation boundary at 1100 ft asl. Boring HSA 9 was spudded at ~ 1124 ft asl and bored to a depth of 26.5' (~1097.5 ft asl), with samples collected every 5 feet. Boring HSA 10 was spudded at ~1127 ft asl and bored to a depth of 15.5' (~1111.5 ft asl), with samples collected every 5 feet.

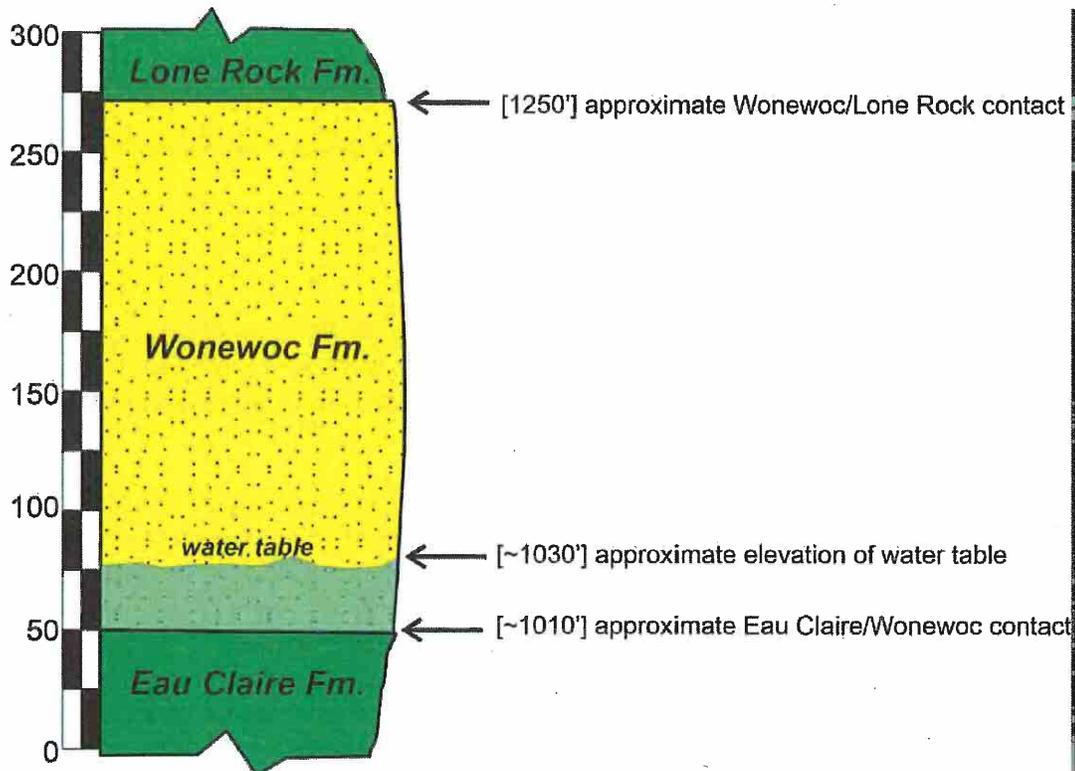
Figure 4: Schematic stratigraphic framework of Paleozoic strata and simplified hydrogeologic profile, Elk Creek drainage, western Chippewa County. Note position of Eau Claire/Wonewoc formations at base of regional aquifer. Note position of Wonewoc/Lone Rock formation contact at -1250' asl, corresponding the height of elongate ridges in area.

Recent mapping, soil borings and drill core indicate that the contact between the base of the Wonewoc Formation and the underlying Eau Claire Formation occurs at ~1010 to 1015 ft asl (Figure 4). The relatively impermeable strata of the fine-grained Eau Claire Formation apparently forms the base of the local surficial aquifer at the base of the Wonewoc Formation. The upper contact of the Wonewoc Formation below the overlying Lone Rock Formation of the Tunnel City Group occurs at ~1240 to 1250 ft asl. There is no contact between Paleozoic bedrock units at 1100 ft asl.

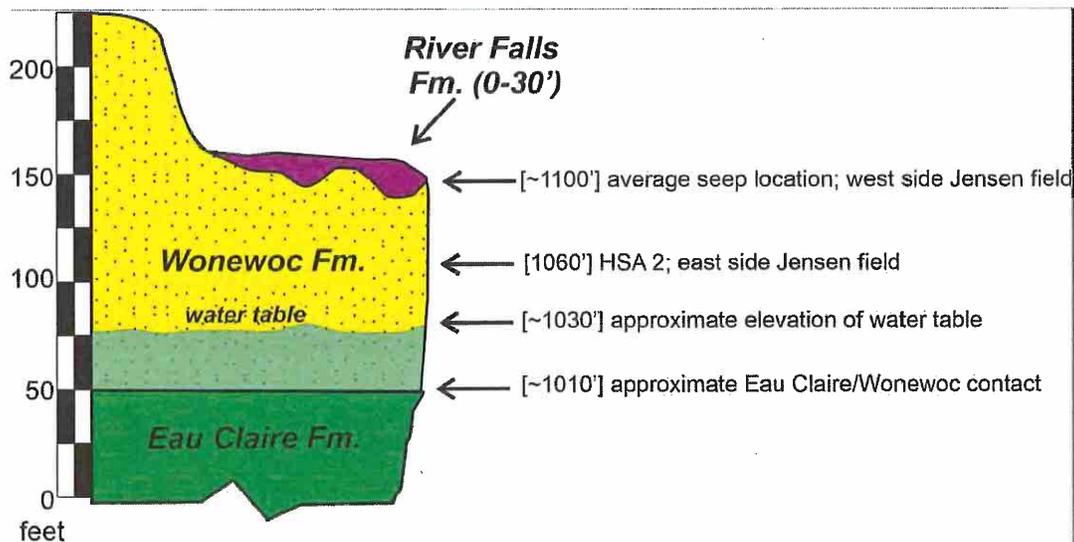
Figure 5: Schematic post-glacial topographic profile, stratigraphic setting and hydrogeologic profile, Elk Creek drainage, western Chippewa County. Note position of primary aquifer at the base of the Wonewoc Formation, relative to the impermeable zones and resultant seeps associated with the thin, lenticular mantle of River Falls Formation.

Paleozoic bedrock in the region was weathered and eroded by post-glacial fluvial activity as the glacial ice of the Chippewa Lobe retreated about 12,000 years ago (Syverson, 2007). This erosion led to the valley and ridge topography that characterizes the Chippewa River watershed today. The ridges tend to be capped by lesser permeable units such as the Lone Rock Formation or strongly cemented sandstone of the upper Wonewoc Formation. Valleys have been eroded to just above the Wonewoc/Eau Claire formation contact, and the Eau Claire Formation tends to form an aquitard that controls the base of the local aquifer. Post-glacial meltwater activity resulted in the deposition of highly irregular (0-30'), lenticular, unstratified, poorly sorted clastic sediment known as the River Falls Formation unconformably above the Wonewoc Formation (Syverson, 2007; Figure 5). The River Falls Formation is generally restricted to the valley bottoms, at elevations at or below ~1120 ft asl.

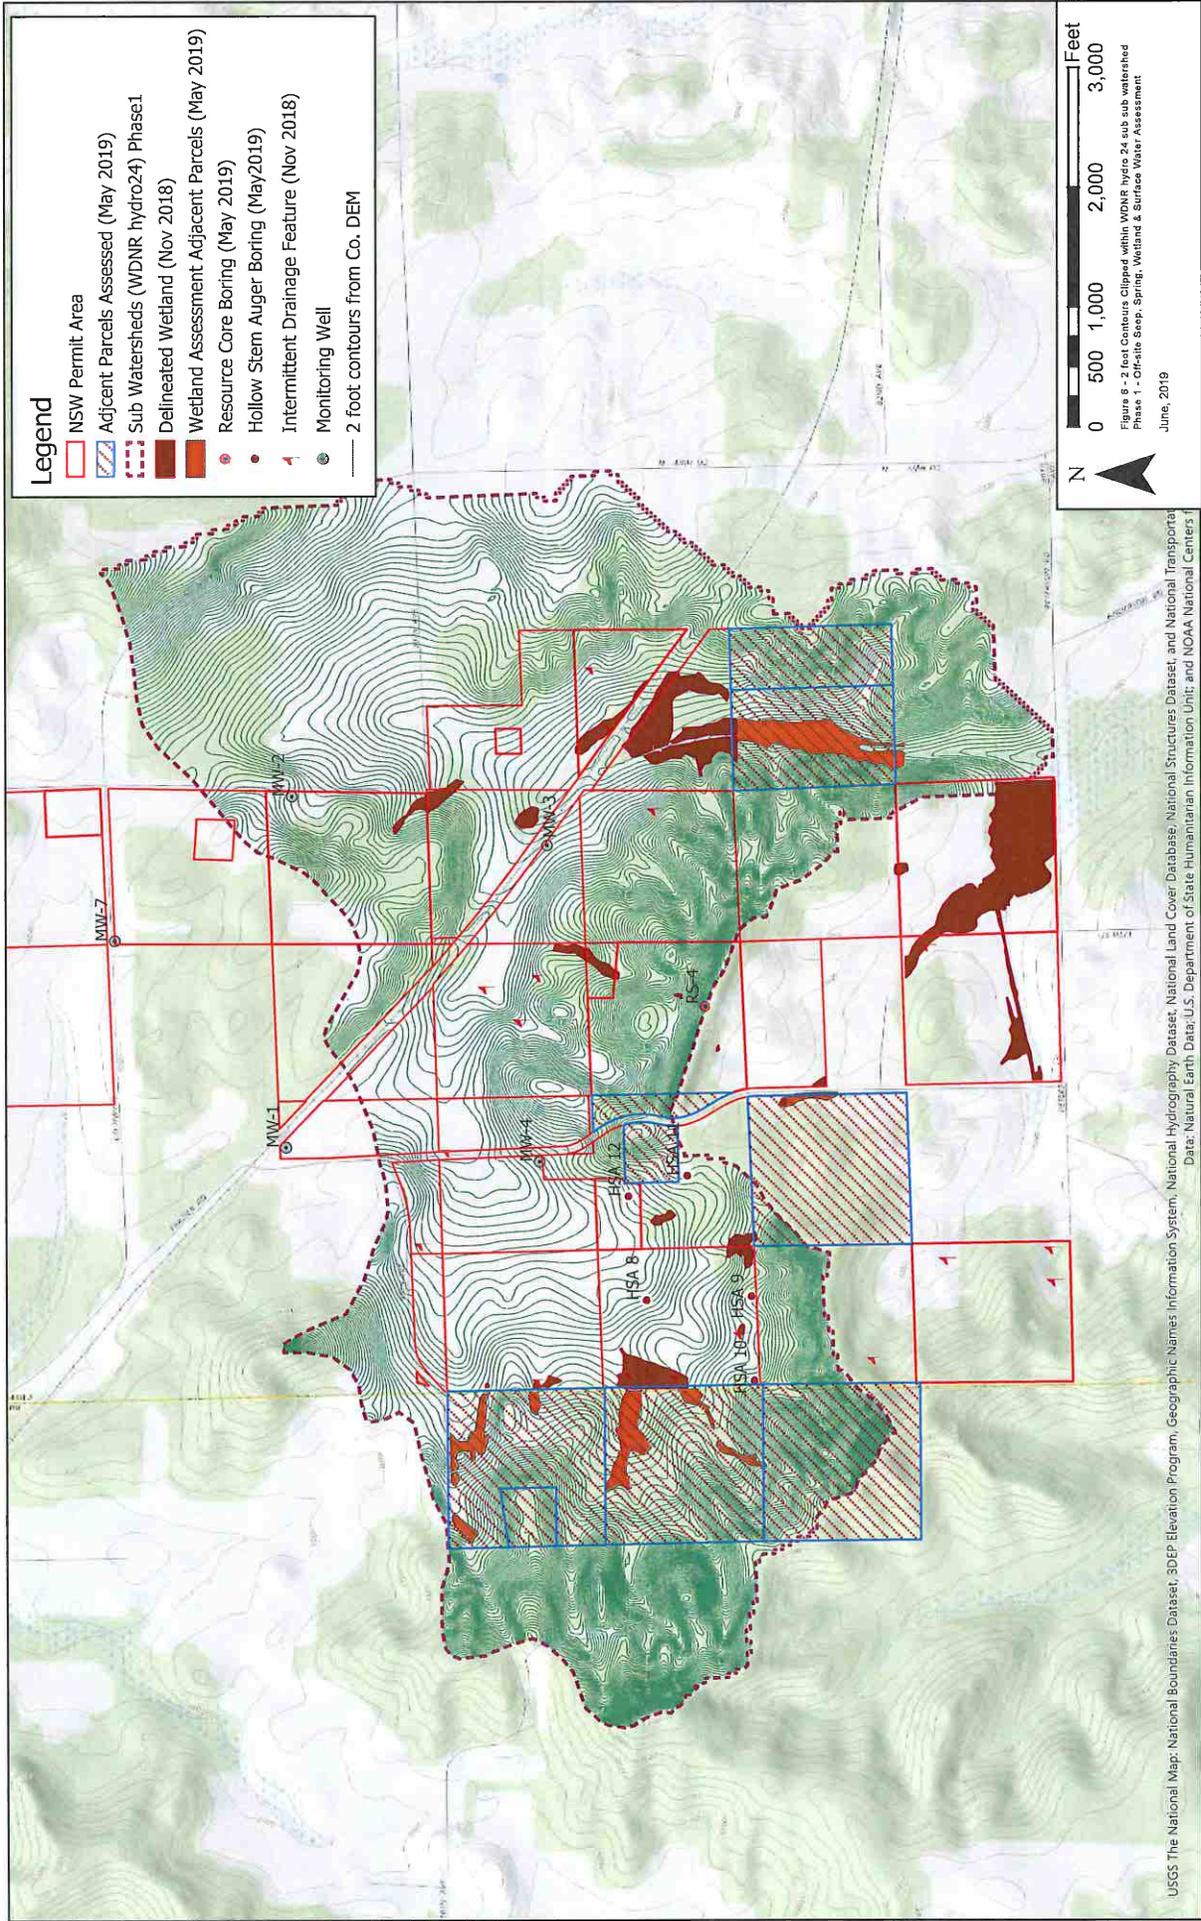
Figure 6 - 2 foot Contours Clipped within WDNR hydro 24 sub watershed Phase 1 - Offsite Seep, Spring, Wetland & Surface Water Assessment June, 2019

The medium to coarse grain size, well rounded and well sorted character of the Wonewoc Formation makes it highly porous and permeable, and, while minor discontinuous clay seams do exist, they are not significant aquitards, and meteoric water rapidly permeates into the subsurface. Conversely, the River Falls Formation contains a wide range of grain sizes (boulders to clay), tends to be rich in clay, and locally forms impermeable horizons that interrupt infiltration of meteoric water. These impermeable horizons are recognized by seeps that are localized above the contact between the River Falls Formation and the Wonewoc Formation at or below ~1120 ft asl. Seeps and wetlands are encountered within this general elevation, as typified by the occurrence of wetlands along the western boundary of Phase I (Figure 6).

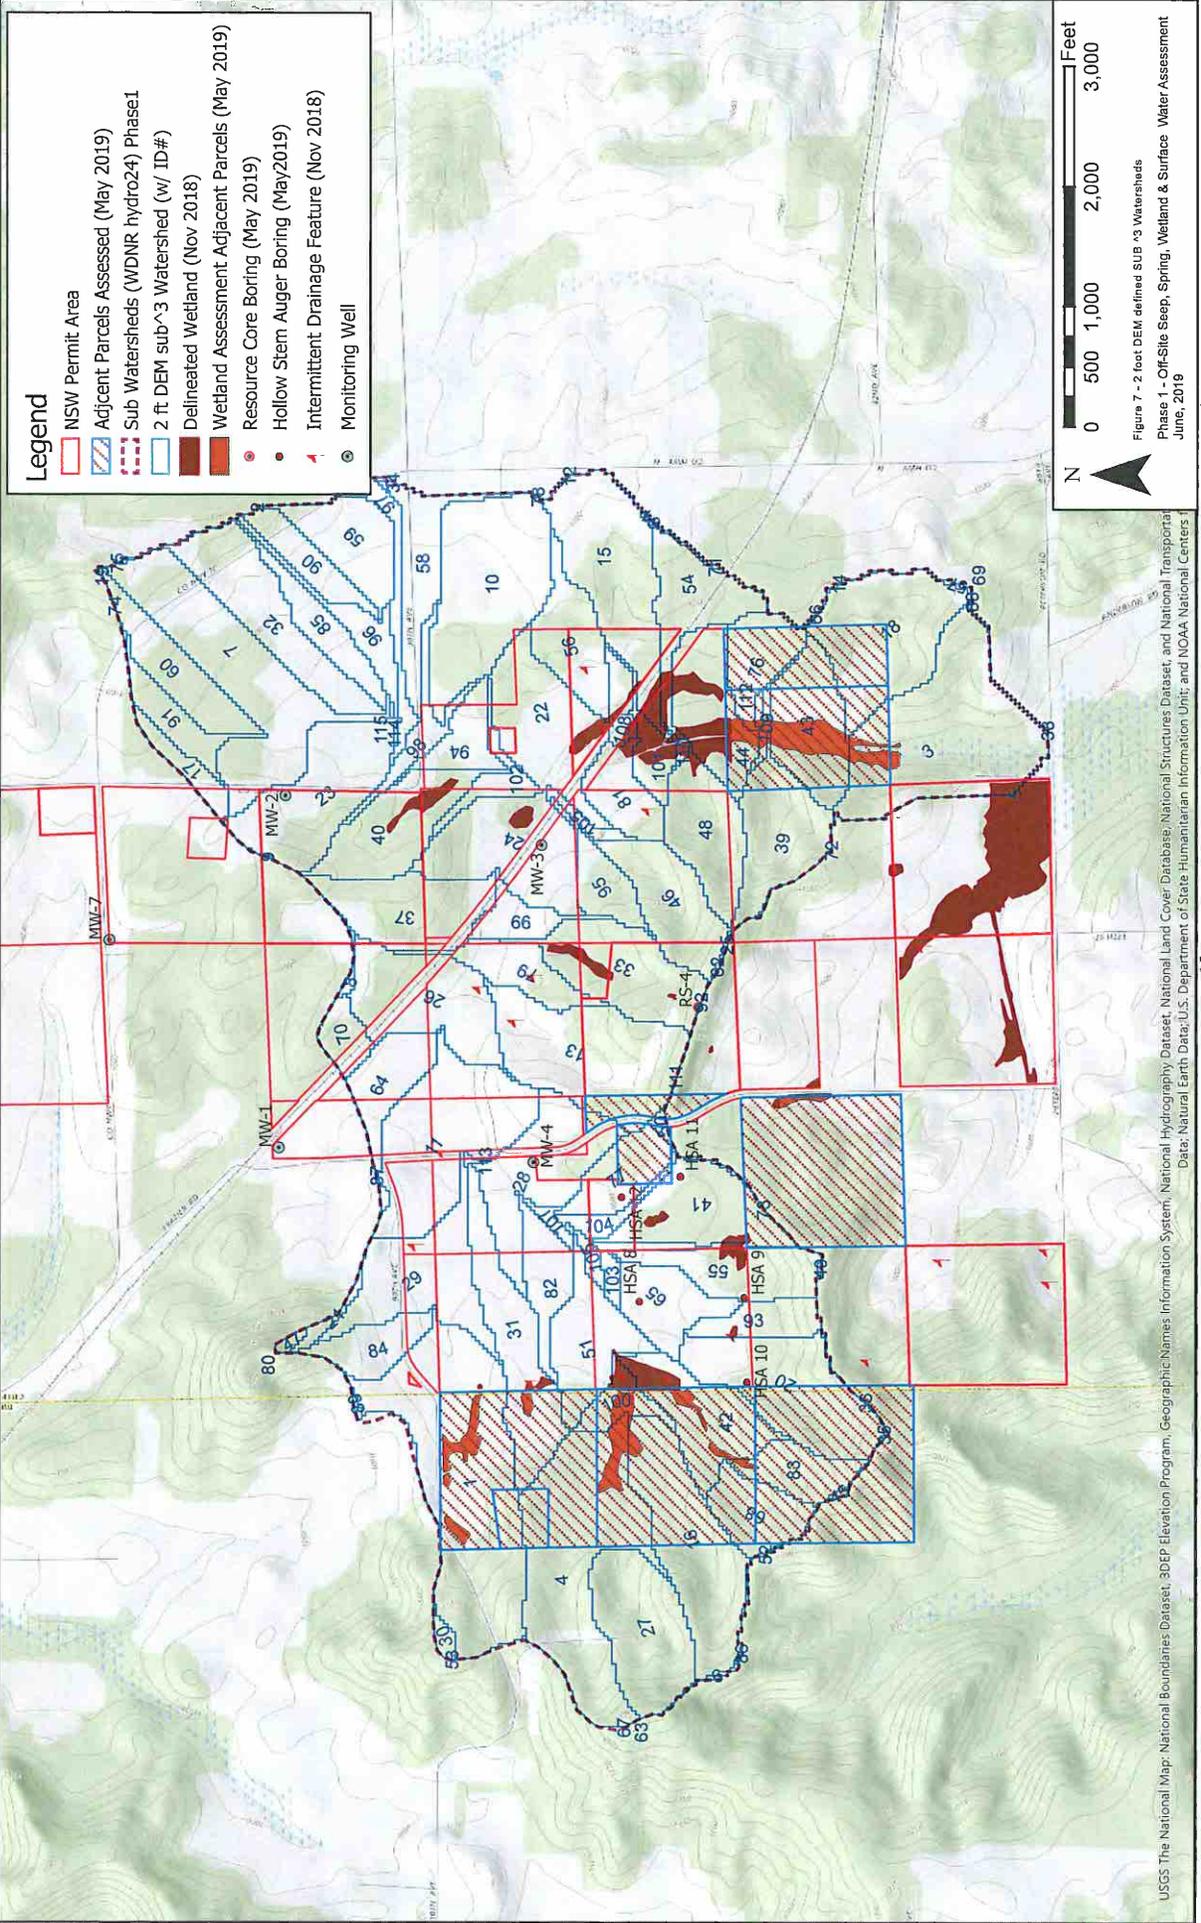
Figure 7 - 2 foot DEM defined sub^3 Watersheds
 Phase 1 - Off-Site Seep, Spring, Wetland & Surface Water Assessment
 June, 2019

Delineation of internal drainage patterns within the defined sub-subwatershed was accomplished utilizing the Watershed hydrology tool within the Spatial Analyst tool in ArcGIS Pro 2.3.2. This spatial analysis function determines the area of sub-sub-subwatersheds by analysis of the digital elevation model, determination of the flow direction and subsequent calculation of the local catchment area (Figure 7, Table 1). Each sub-sub-subwatershed is defined by flanking drainage divides, and each has a common outlet, or pour point, which allows hydrologic flow paths to be determined (Figure 8). The percent contribution of surface and subsurface water to the overall water budget is assumed proportional to the acreage within each sub-sub-subwatershed.

Of the 115 sub-sub-subwatersheds identified within the sub-subwatershed area, 17 (4.7%, 44.9 acres) are fully within the Phase I permitted area, and 36 (22.9%, 219.2 acres) are outside of the permitted area. The remaining 62 sub-sub-subwatershed intercept the Phase 1 boundary and occupy 692.9 acres or 72.4%. Fully 95.3% of sub-sub-subwatersheds outside of the Phase I permit area flow into the Phase I area. Adjacent properties to the west (Wagner, Frisch and Stahl properties) drain entirely into the Phase 1 project area. Adjacent properties to the south (Smit) drainage into the sub-subwatershed to the south with the exception of 2.5 acres in the northwest corner that drains to the north. The entire sub-subwatershed,

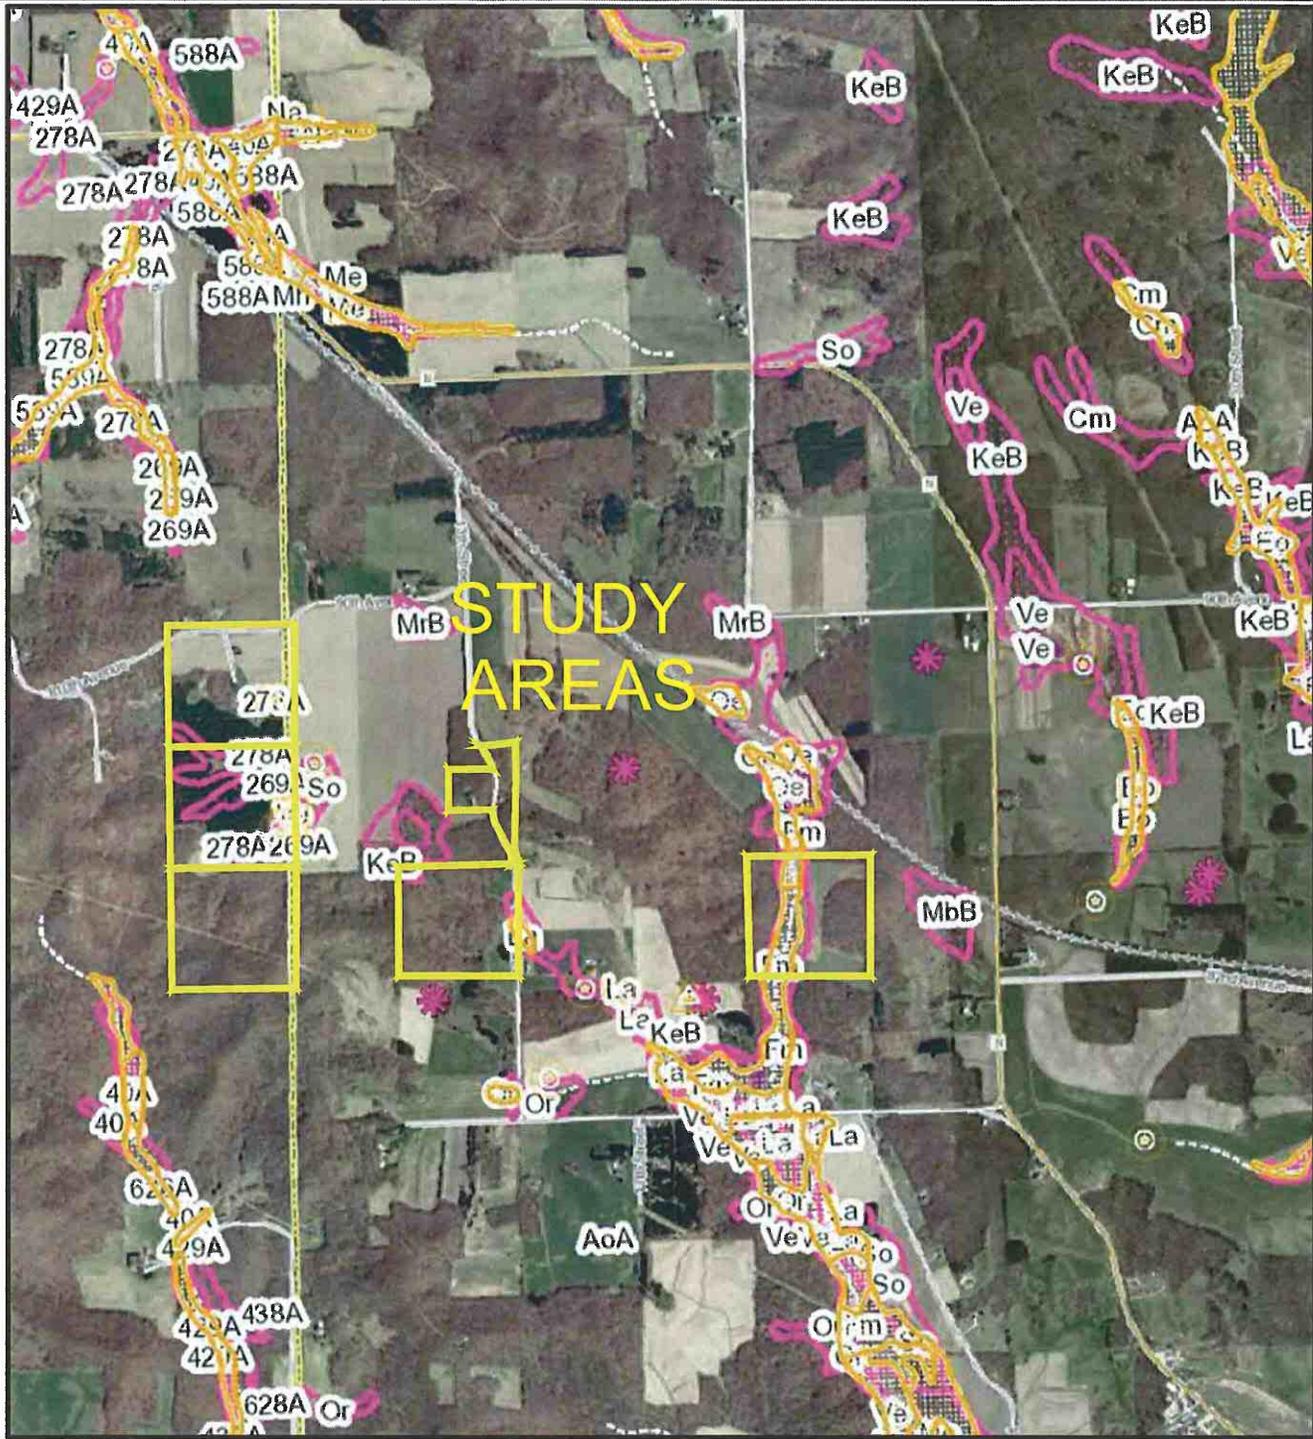
Figure 9: Wisconsin Wetland Inventory map of the Elk Creek and Eighteen Mile drainage basins. Note location of off-site properties being evaluated.

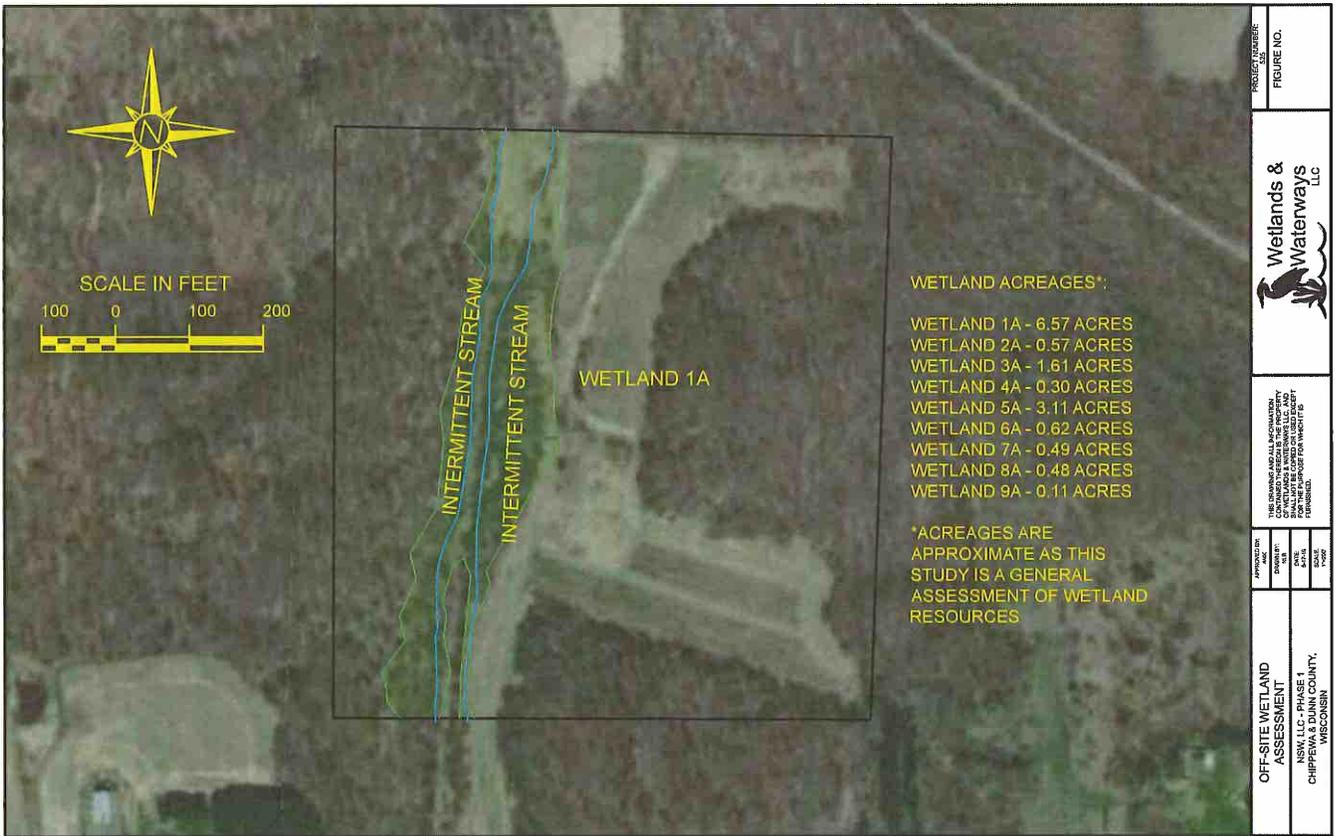
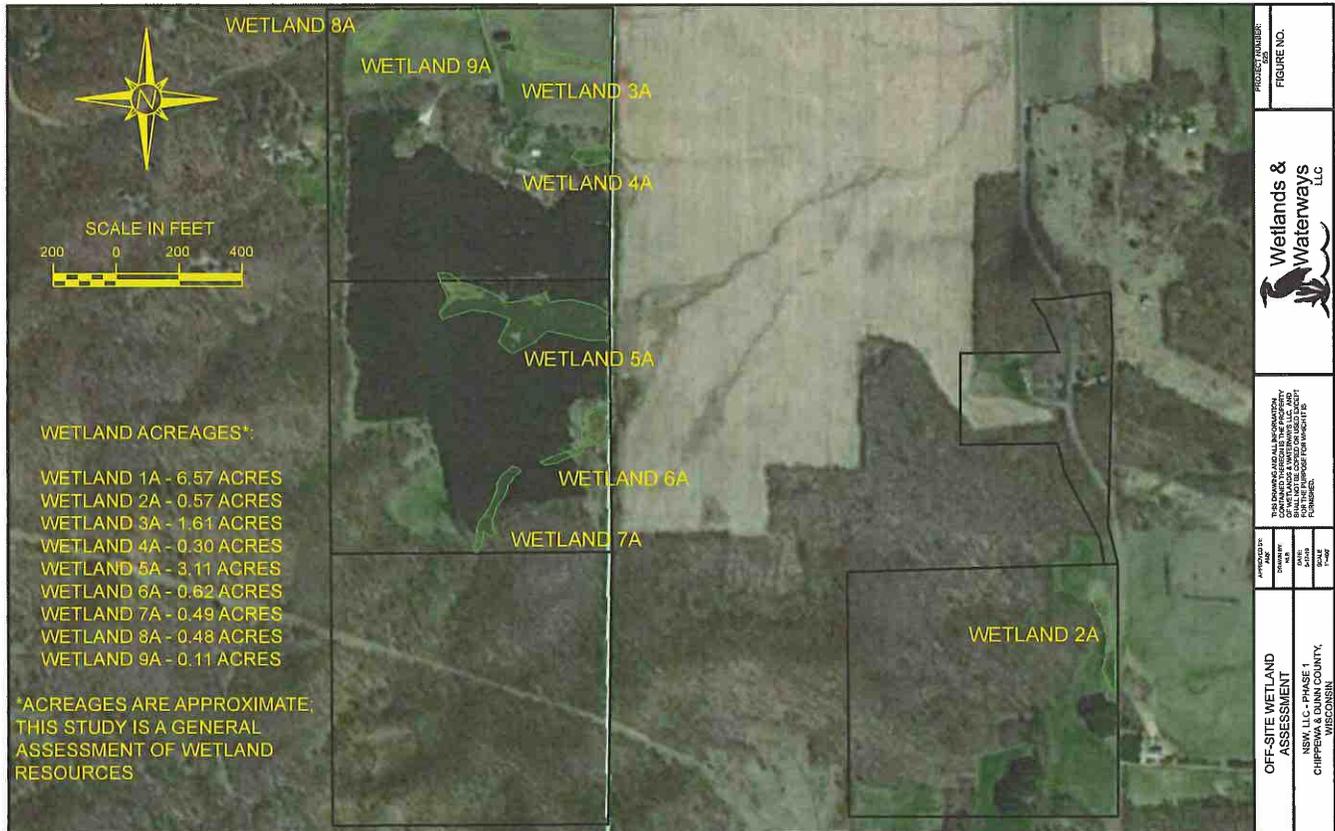
Figure 10: General assessment of wetland resources of properties adjacent to the Phase 1 project area. Compare with wetland areas within Phase 1, shown on Figure 1, and with the sub-sub-subbasin hydrology illustrated in Figure 8.

Nine (9) wetlands were identified during the site visits (Figure 10). The identified wetlands, community types and noted features are discussed in further detail below:

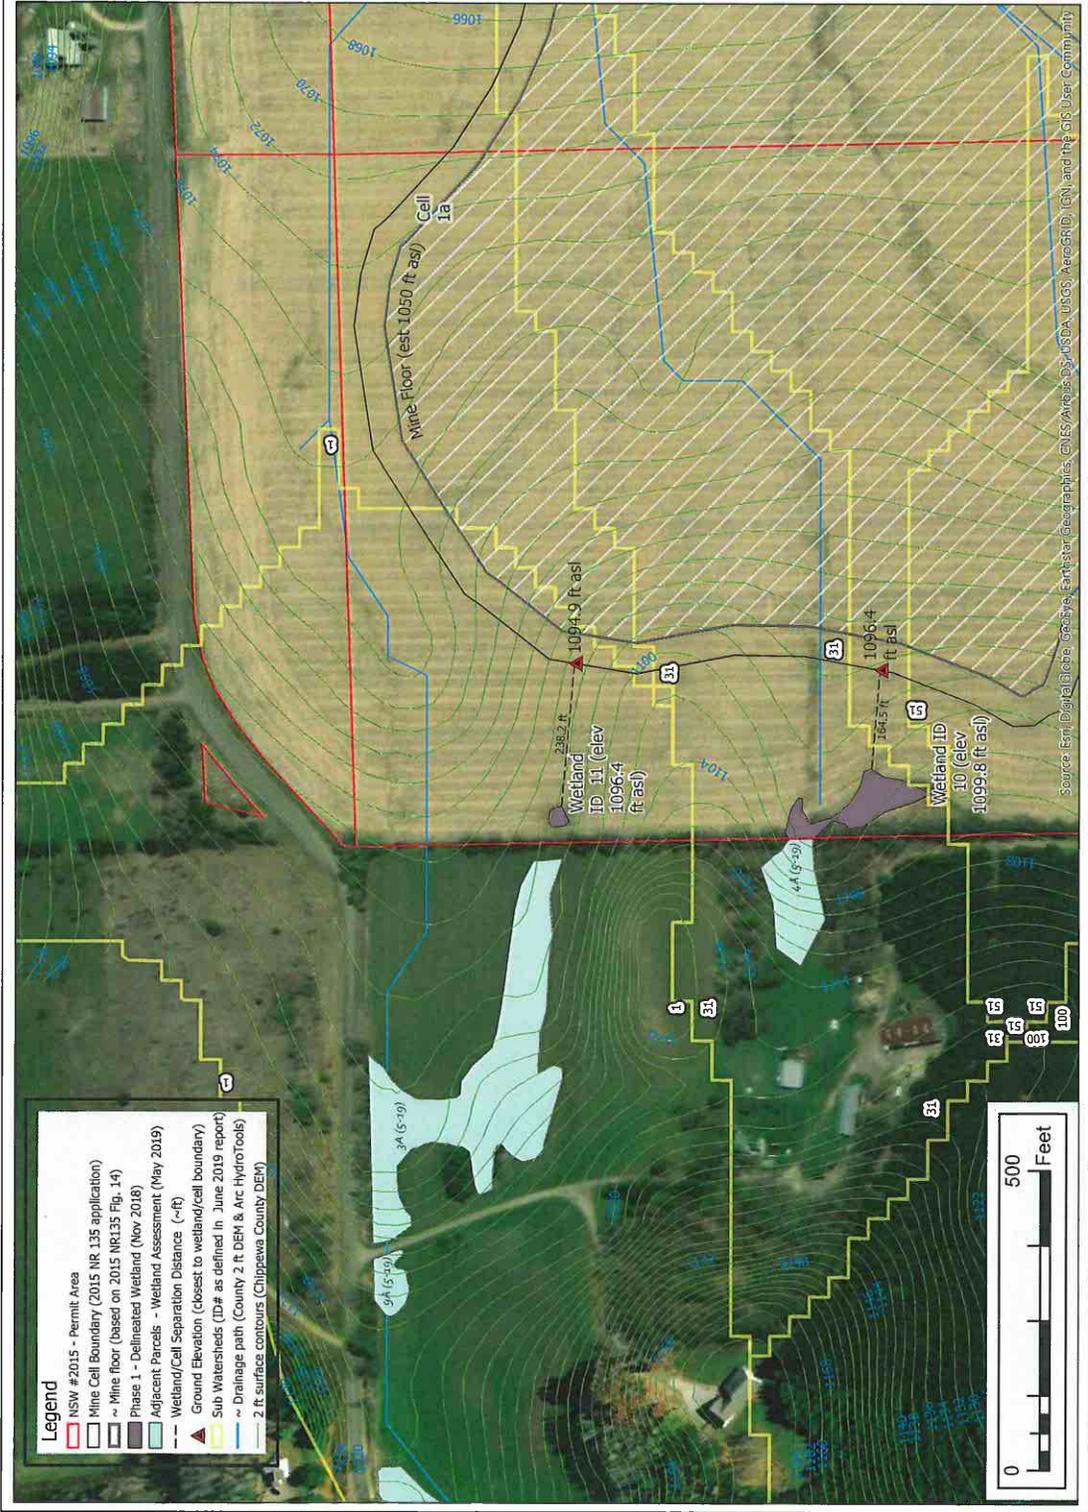
Phase 1
 Mine Cell 1a
 Wetland # 11&10
 Watershed # 1 & 31
 Chippewa County - Chapter 17
 Permit # 2015-1

Separation distances and surface elevation are highlighted on the figures. Contour elevations are also shown and were created from raster interpretation of the Chippewa Count Digital Elevation Model (DEM). Wetlands along the western permitted area discharge to the east toward 13th St. and the down gradient elevations are labeled along with the elevation of the Cell 1a and Cell 1b boundary closest to the wetland.

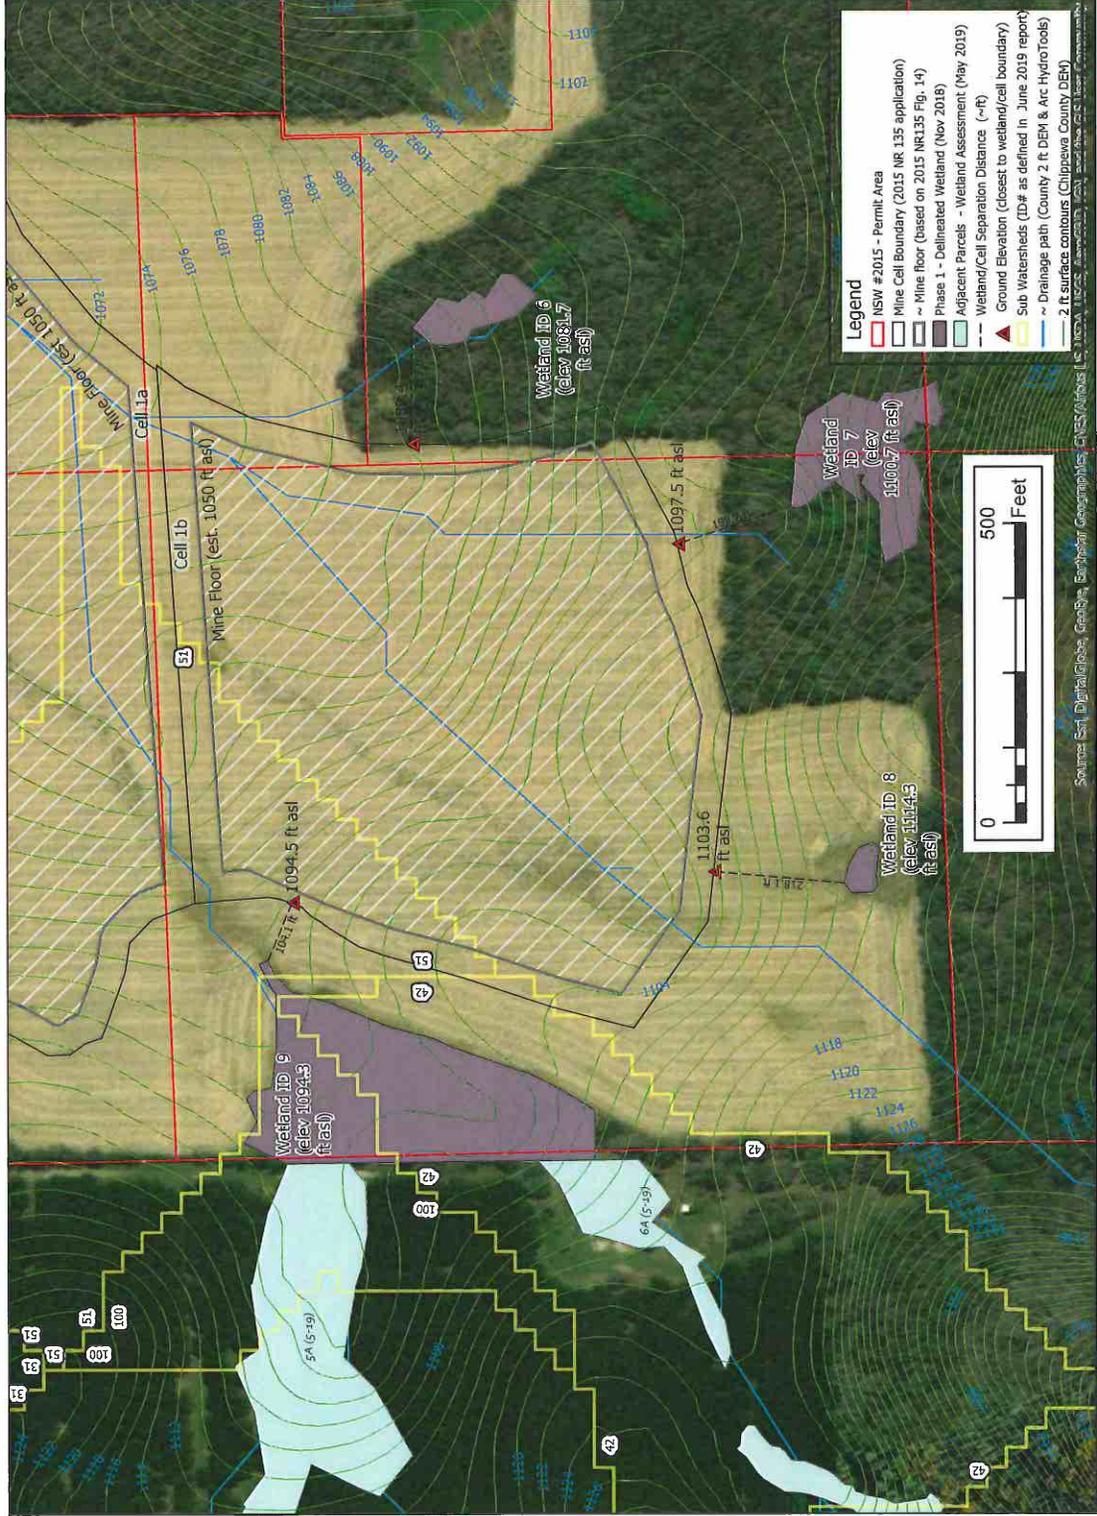
Figure 2 (revised)

Phase 1
 Mine Cell 1b (revised 9/19/19)
 Wetland # 6 - 9
 Watershed # 42, 51, 100
 Chippewa County - Chapter 17
 Permit #2015-1

The NR135 applications states a minimum of 75 ft separation distance (buffer) from wetlands (section 2.1 Area and Setbacks p. 14). Wetland ID # 9 (7-18) delineation may cause the 1B cell western boundary to be adjusted to maintain the minimum 75 feet set back distance following review of the construction survey and staking.
