WETLAND DELINEATION REPORT

John & Marie Clark, ETAL.

T31N R10W SECTION 28

DRT SANDS INC

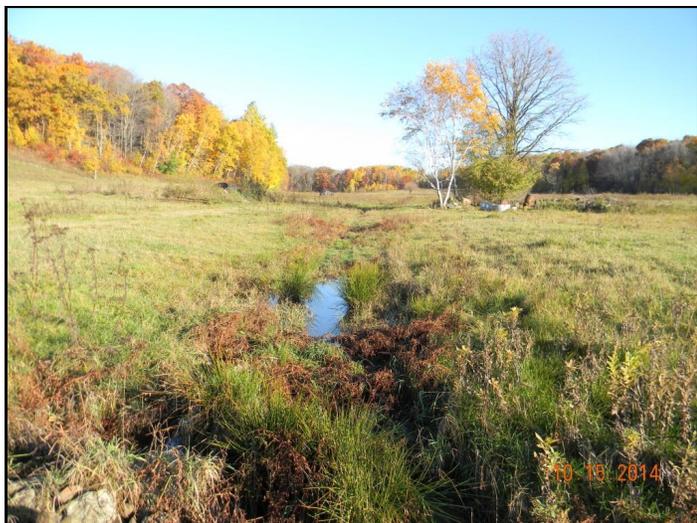
The length of channel through the pastureland is about 1392 feet. The channel dimensions ranged from about 13 to 18 foot top width, 4 to 8 foot bottom width, and a depth of 2 to 2 1/2 feet. The photos below were taken from the same location, near the fenceline between the pastureland and the cropland.

LOOKING UPSTREAM AT CHANNEL IN PASTURE

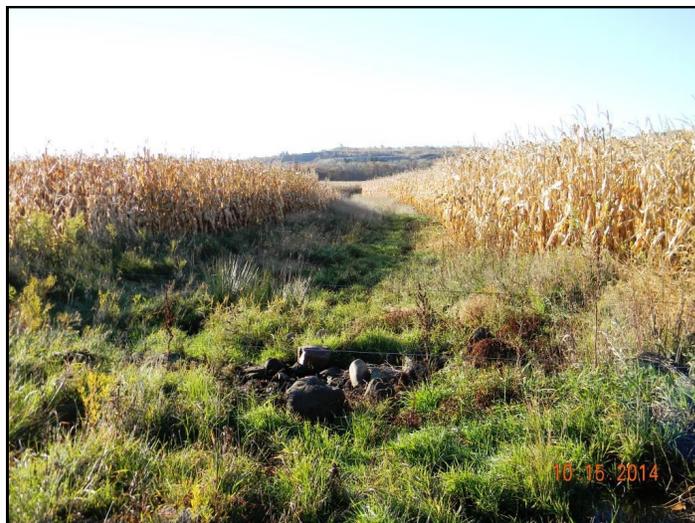
LOOKING DOWNSTREAM AT CHANNEL IN CROPFIELD

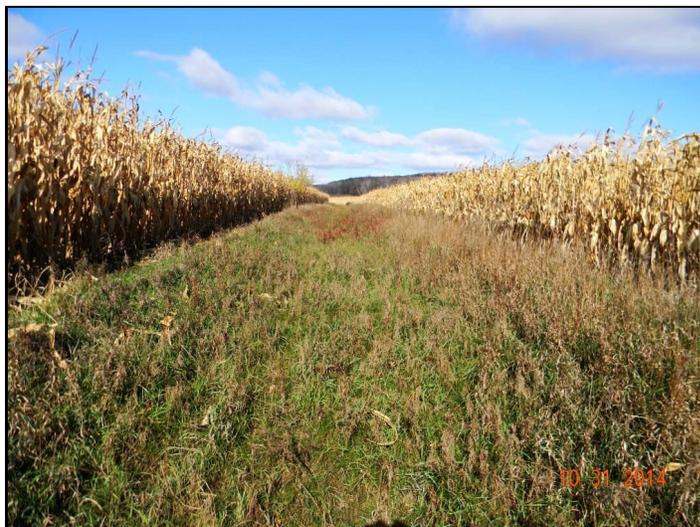
Downstream from the pastureland, the intermittent stream then flows through a grassed waterway between the cropfields for about 1255 feet where it reaches HWY 64. The total drainage area to this point is about 184 acres. The photo at the right was taken from Information Point IP4 looking upstream in the grassed waterway between the fields. The soil in this area was mapped the Scott Lake loam. The aerial photo review did not show any wet signatures within this waterway.

LOOKING UPSTREAM FROM IP4

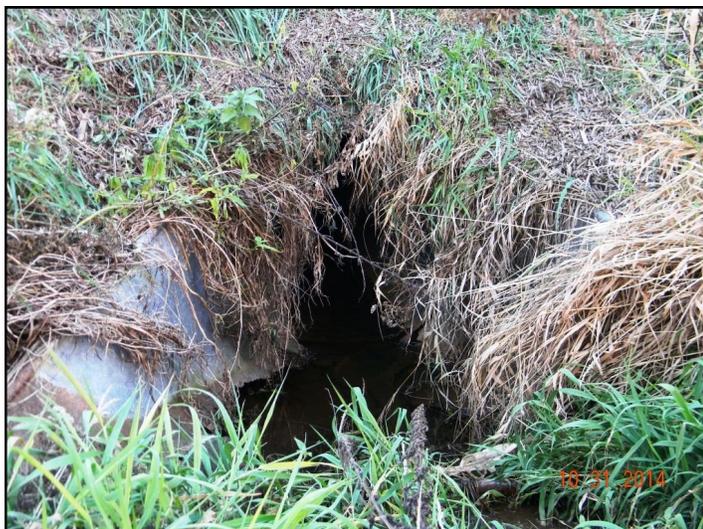
INLET SIDE OF 32" CMP WITH WINGWALLS

There is also a 32 inch CMP culvert with wingwalls located under 30th Street. It is the outlet for the water from the small wetland on the northeast corner of the junction of HWY 64 and 30th Street. The photo on the right is of the inlet end of the culvert. This is the same type of culvert that is under HWY 64.

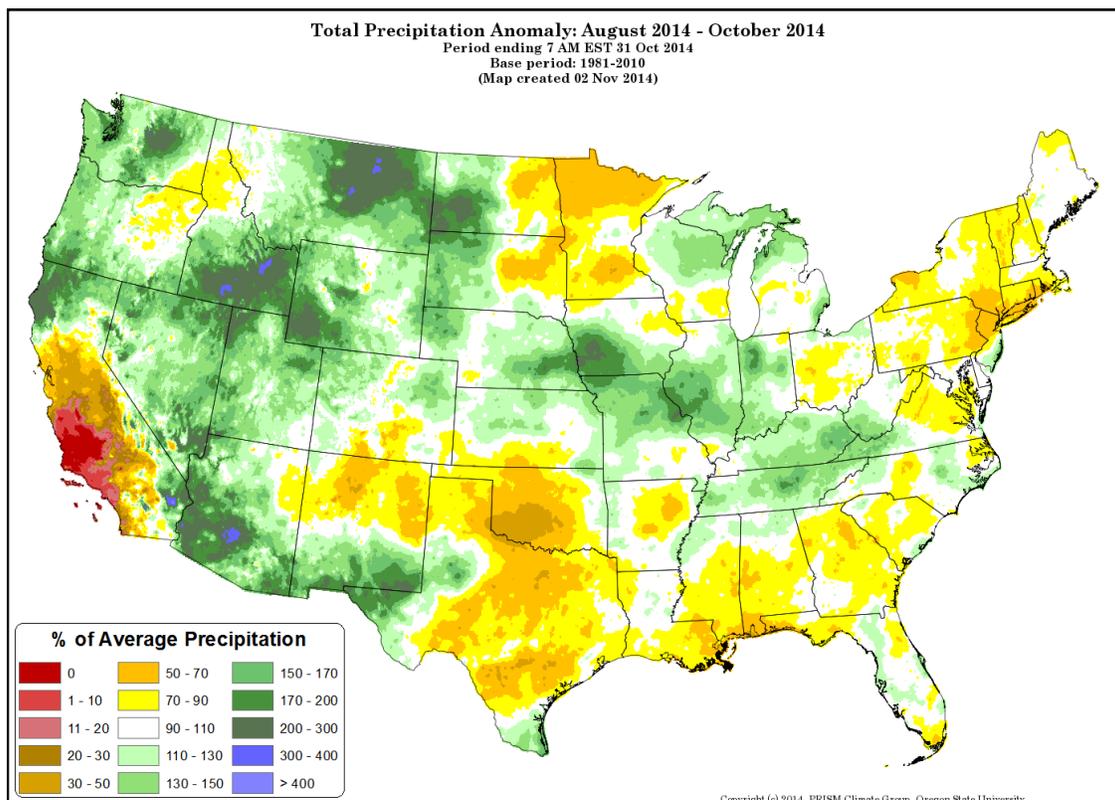
The graphic below was compiled by the PRISM group. The total rainfall for August 1 to October 31 was 14.53 inches, which is 108.7% of normal range. The graphic below shows the area experiencing 110 to 130% of normal range precipitation for that same time period.

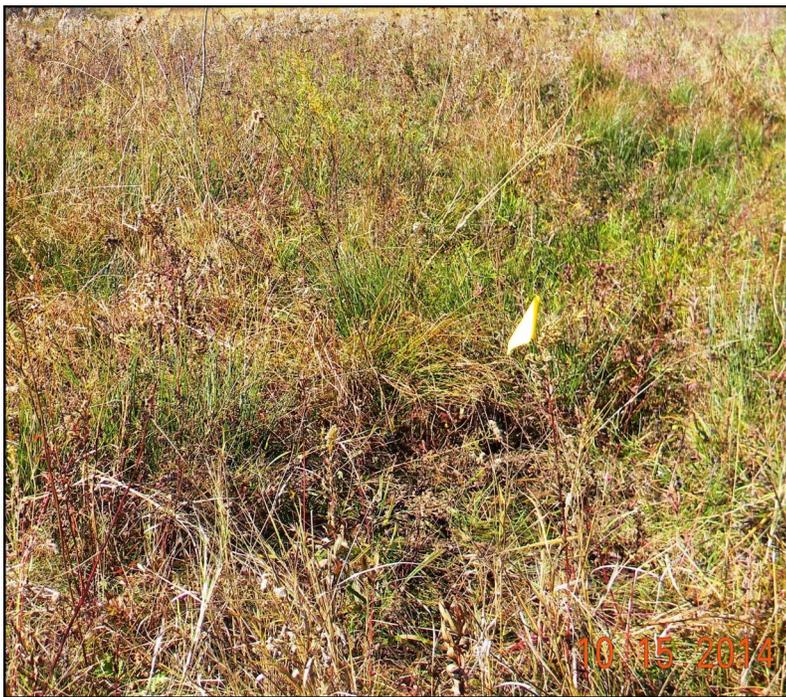
AT SAMPLE POINT T2H4

The area where the Transect 2 Sample Points and IP1 were located is on an upland terrace. This terrace is approximately 20 feet above the elevation of the intermittent stream. The area was slightly depressional and surface water was present at the time of the survey. IP1 soil pit was found to be a Depleted Matrix (F3) with Hydrogen Sulfide odor (A4) with Redox of 25% in the upper 12 inches of the soil profile. T2H4 was saturated to the surface, and was also a Depleted Matrix (F3) and Depleted Below Dark Surface (A11), with Redox of greater than 25% in the upper 12 inches of the soil profile. Some of the hydrophytic vegetation in this area were: Soft Rush (*Juncus effusus*), Carex sp., Bulrush (*Scirpus cyperinus*) and Canadian bluejoint grass (*Calamagrostis canadensis*). The picture at the right shows the soft rushes, bulrushes, and Carex.

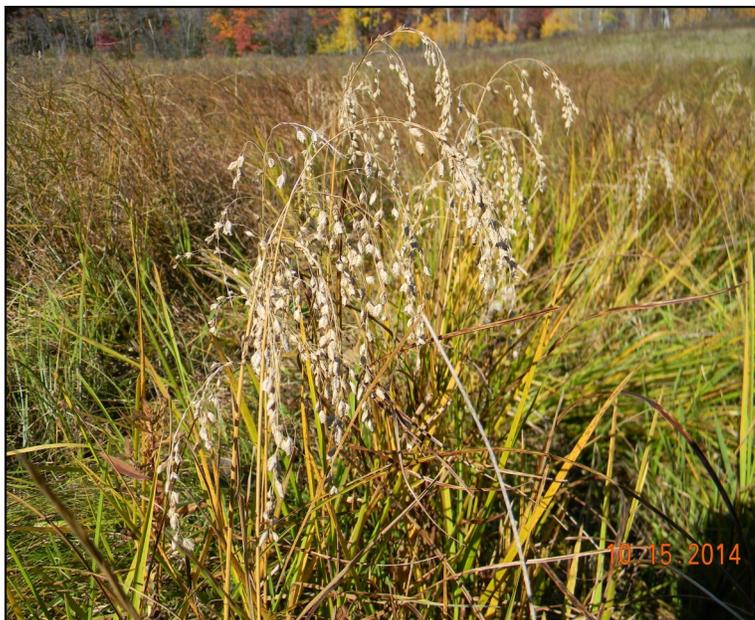
The photo on the left was take at Sample Point T3 H7. This wetland area that was dominated by Rattlesnake manna grass (*Glyceria canadensis*) is adjacent to the un-named stream.

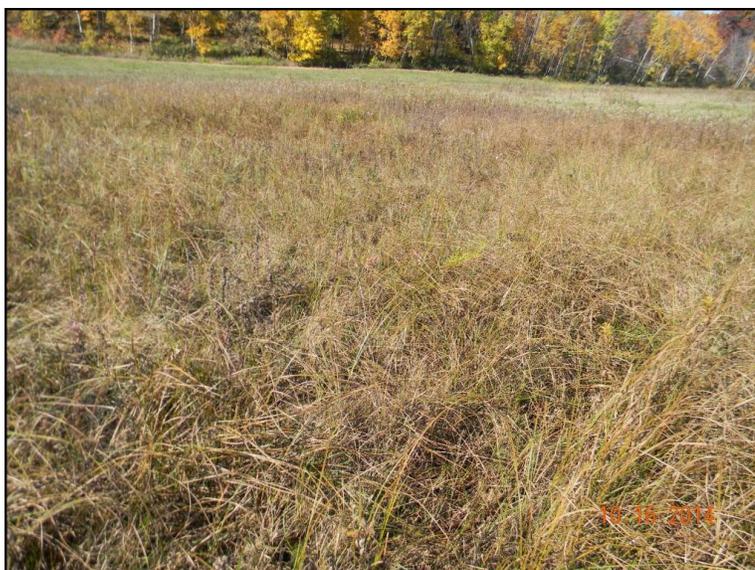
AT T5H13 LOOKING DOWNSTREAM

The wetland boundary that was defined by Transects 5, 6 and 7 in the drainageway had three types of wetlands: a sedge meadow, a wooded wetland, and a wet meadow depressional area. The photo at the left was taken from sample point T5H13 looking downstream in the drainageway at the existing sedge meadow.

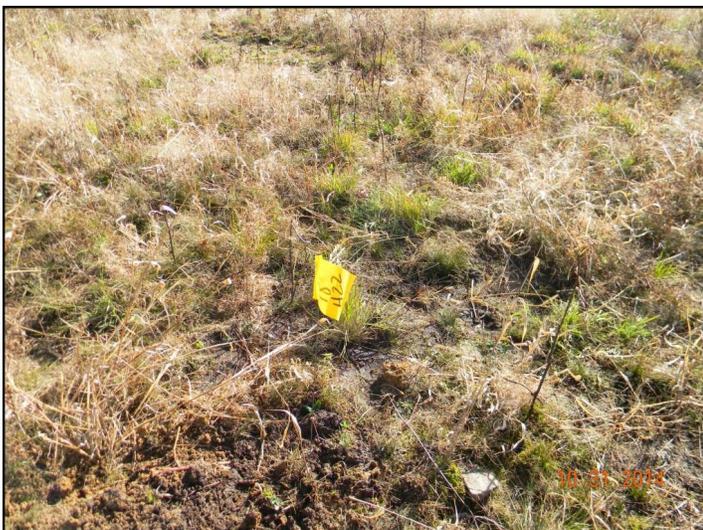
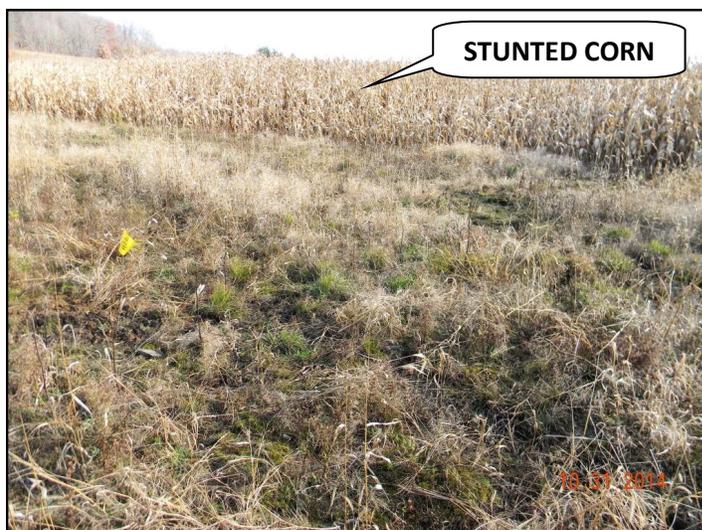
The photos above are at T8H22. This was a disturbed area of the cropland that appeared to be depressional with no outlet. This area was not planted to corn. There are spots within this area that had no vegetation due to ponding. The corn at the edge of the depression was stunted. The aerial photo review of this area showed evidence of wet signatures in most years (**APPENDIX B**).

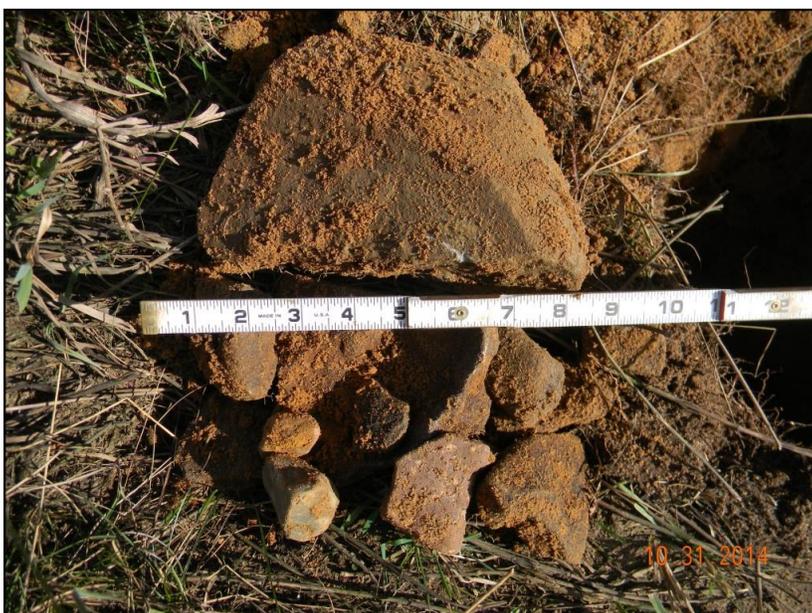
Two Informational Points, IP3 and IP4, were dug and the soils and vegetation documented in the downstream reach of the intermittent stream that was described previously in this report as the grassed waterway. These informational points were selected to verify whether conditions existed to classify this area as a wetland. The soil profile showed no hydric indicators. The soil was 0” to 4” loamy sand, 4” to 16” gravelly sand, and 16” to 23” sand with rocks. The only surface hydrology indicator was that it was a drainageway. The common vegetation in the waterway was bromegrass (*Bromus inermis*), Kentucky bluegrass (*Poa pratensis*), and quackgrass (*Elymus repens*). It was determined that this reach of the intermittent un-named stream did not meet the criteria for a wetland.

ROCKS FOUND IN LOWEST 16” TO 23” LAYER AT IP3 & IP4
