Appendix F

Local Surface Waters and Site Drainage Information

TECHNICAL MEMORANDUM WETLAND DELINEATION REPORT

RE: Dennis Schindler Property Review
SEH No. EOGRE 113677 32.00

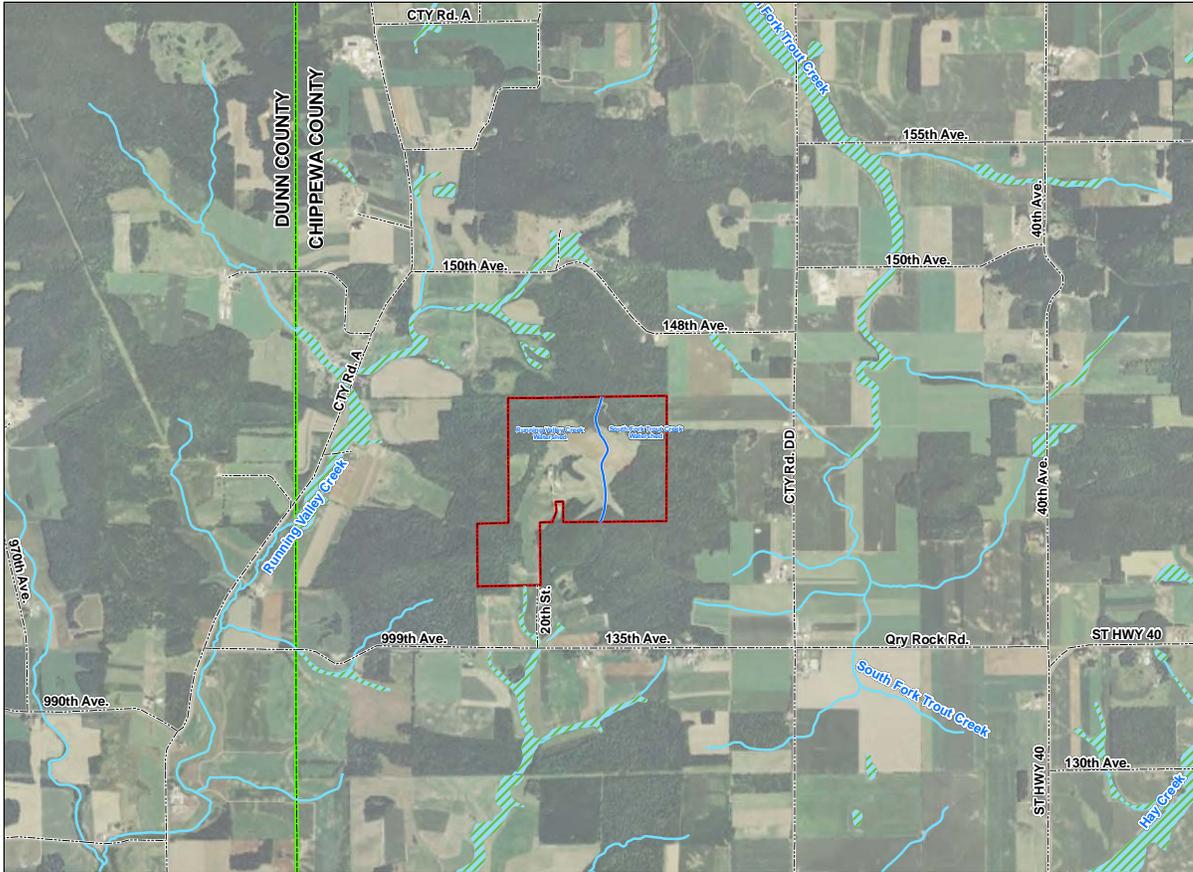
F-1 – Site and Surrounding Features Map

Note:
 Running Valley Creek is classified as a Class II Trout Stream.

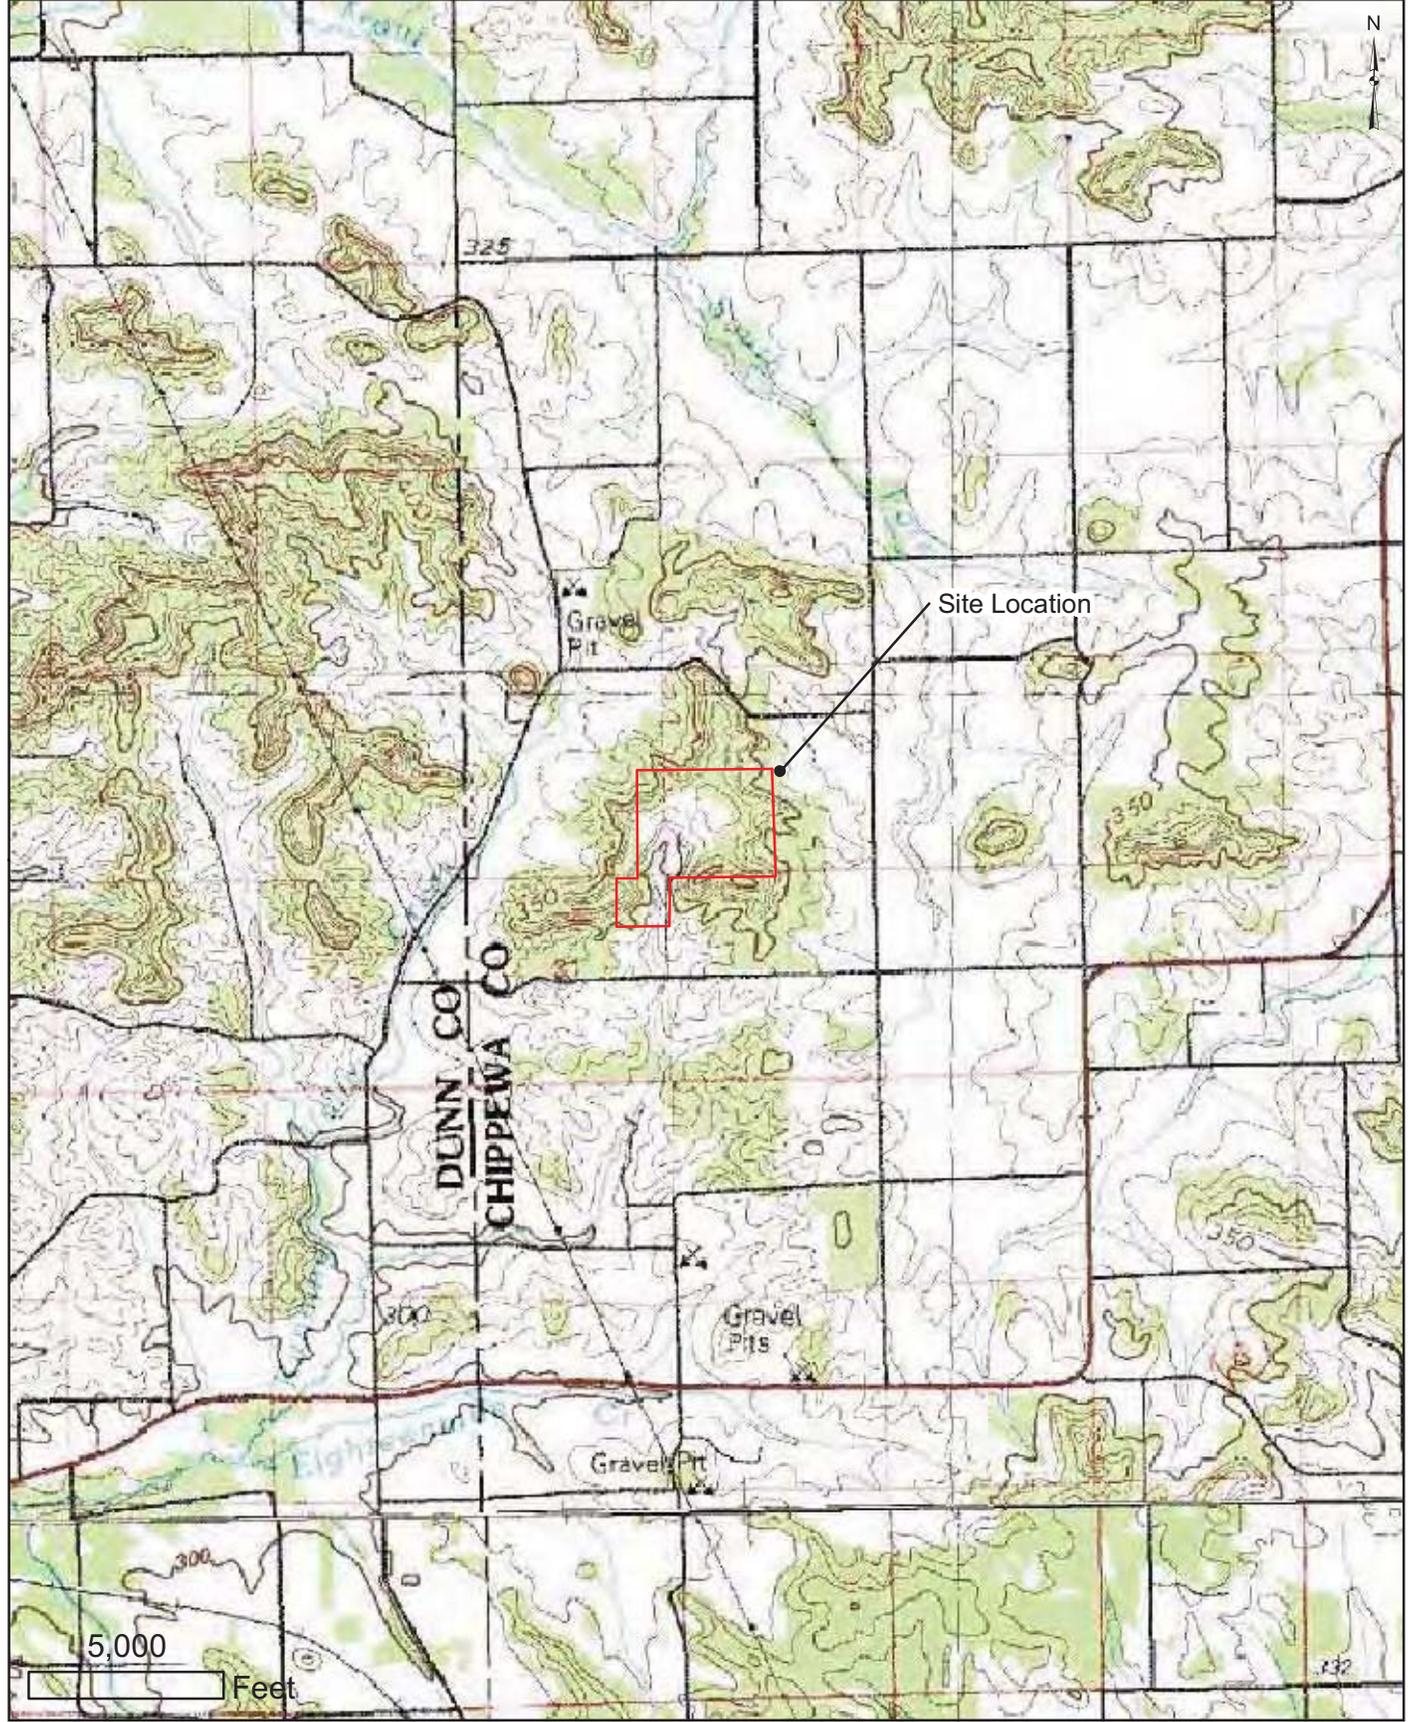
Figure
1

USGS Topographic Map

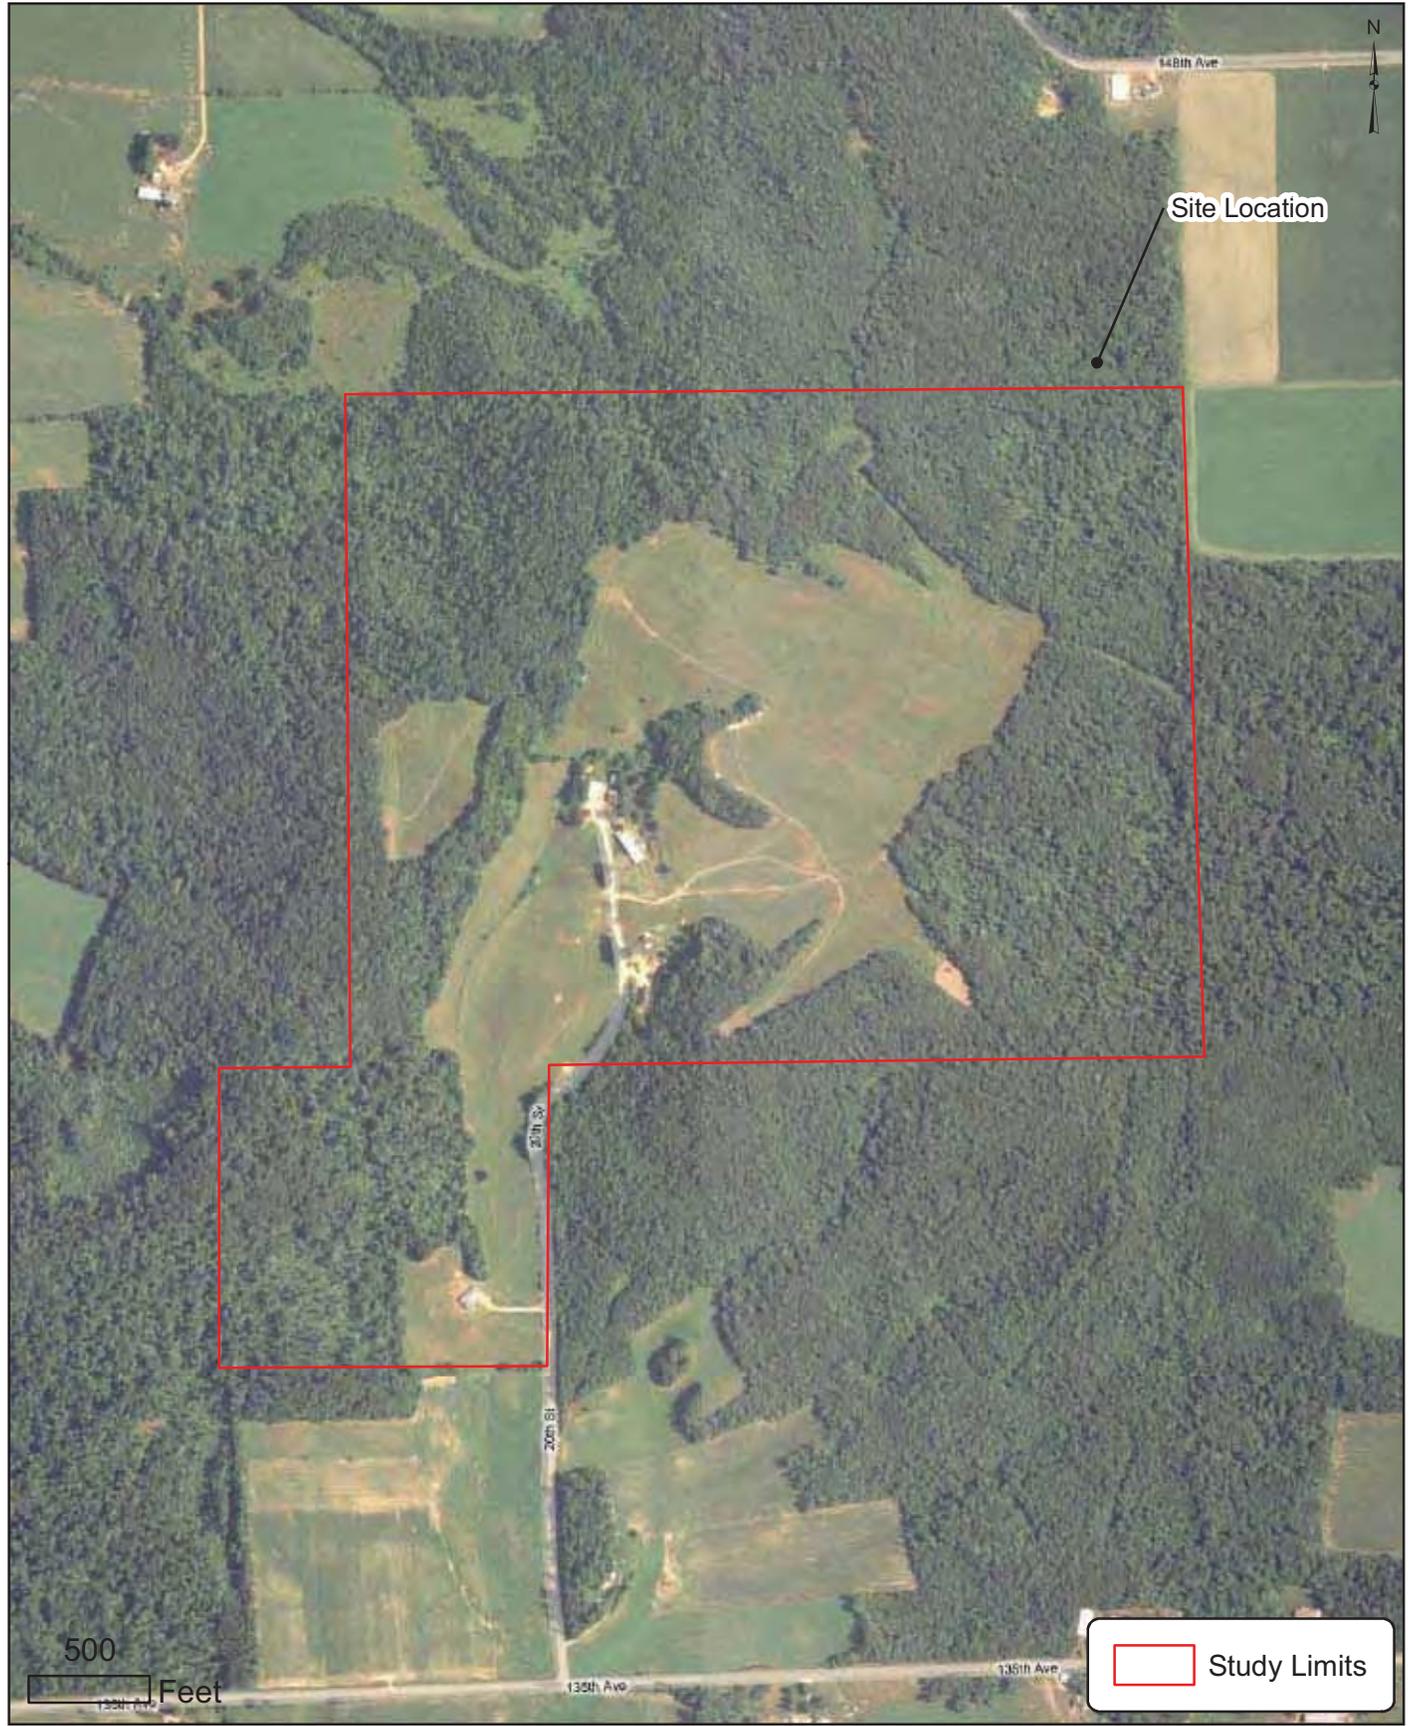
Figure
2

2008 Aerial Photograph

The property contains two residences, a small building used as a business (butcher shop), a barn, and several out-buildings, which can be seen on the 2008 aerial photograph (Figure 2). The center of the site is used as a cattle pasture, but also includes open areas that are used as grassland (either cut or rotated for pasture) and row crops (currently corn). The remainder of the site is wooded. Cover classifications have been mapped in Figure 4.

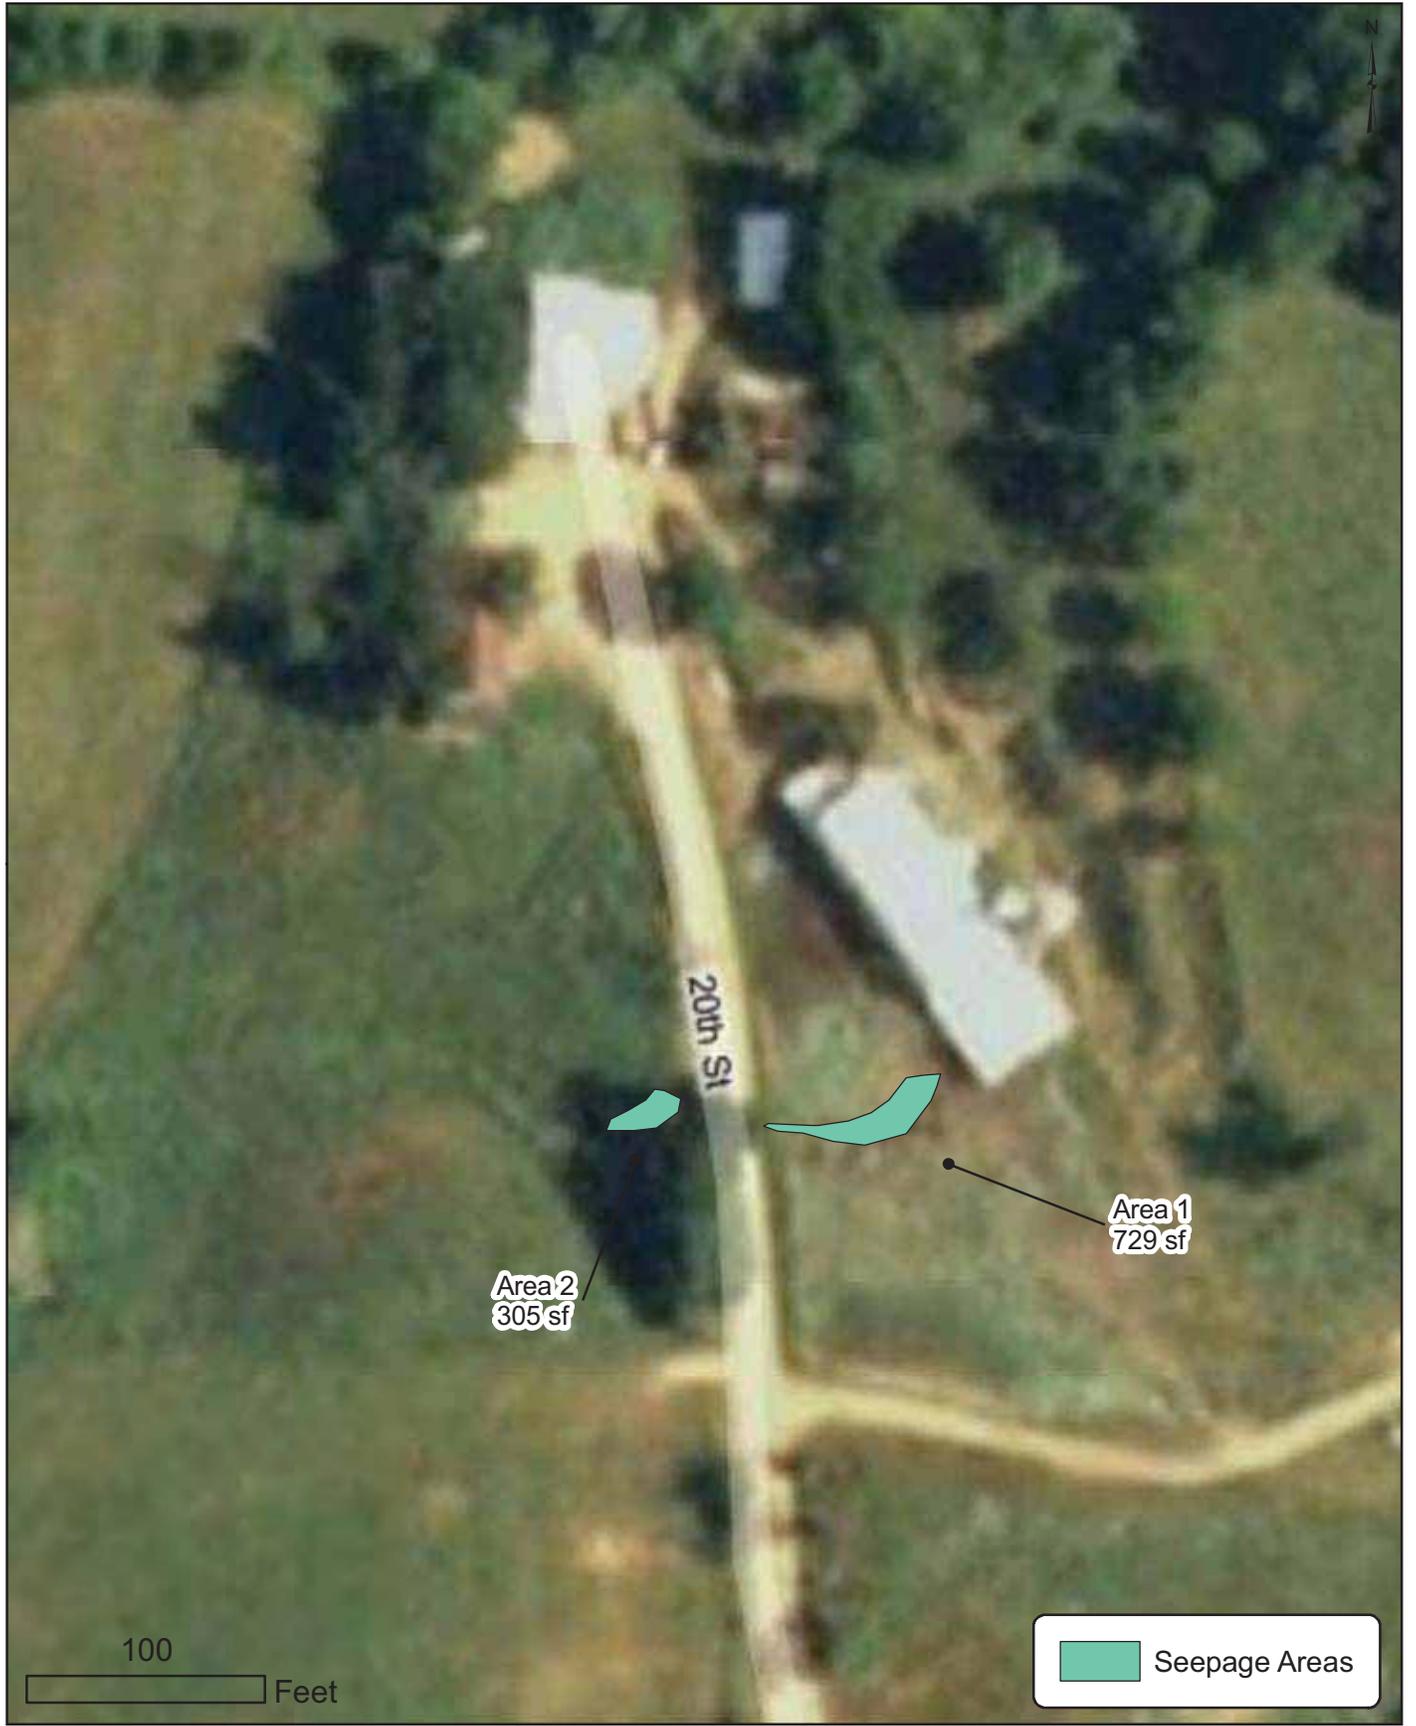
Figure
3

In order to allow for field review, I flagged the extent that hydrology was present in the two seepage areas. This includes an area of 729 square feet on the east side from the source near the corner of the barn to the road, and an area of 305 square feet on the west side of the road. On the west side of the roadway the seepage is present immediately adjacent to the road, but quickly infiltrates so that no hydrology is present within 50 feet of the roadway. A small eroded channel from the spring to the valley bottom is a result of erosion from surface water, as is the collapsed rock and soil along the roadway.

Seepage Areas
Schindler Property
Cooks Valley, Wisconsin

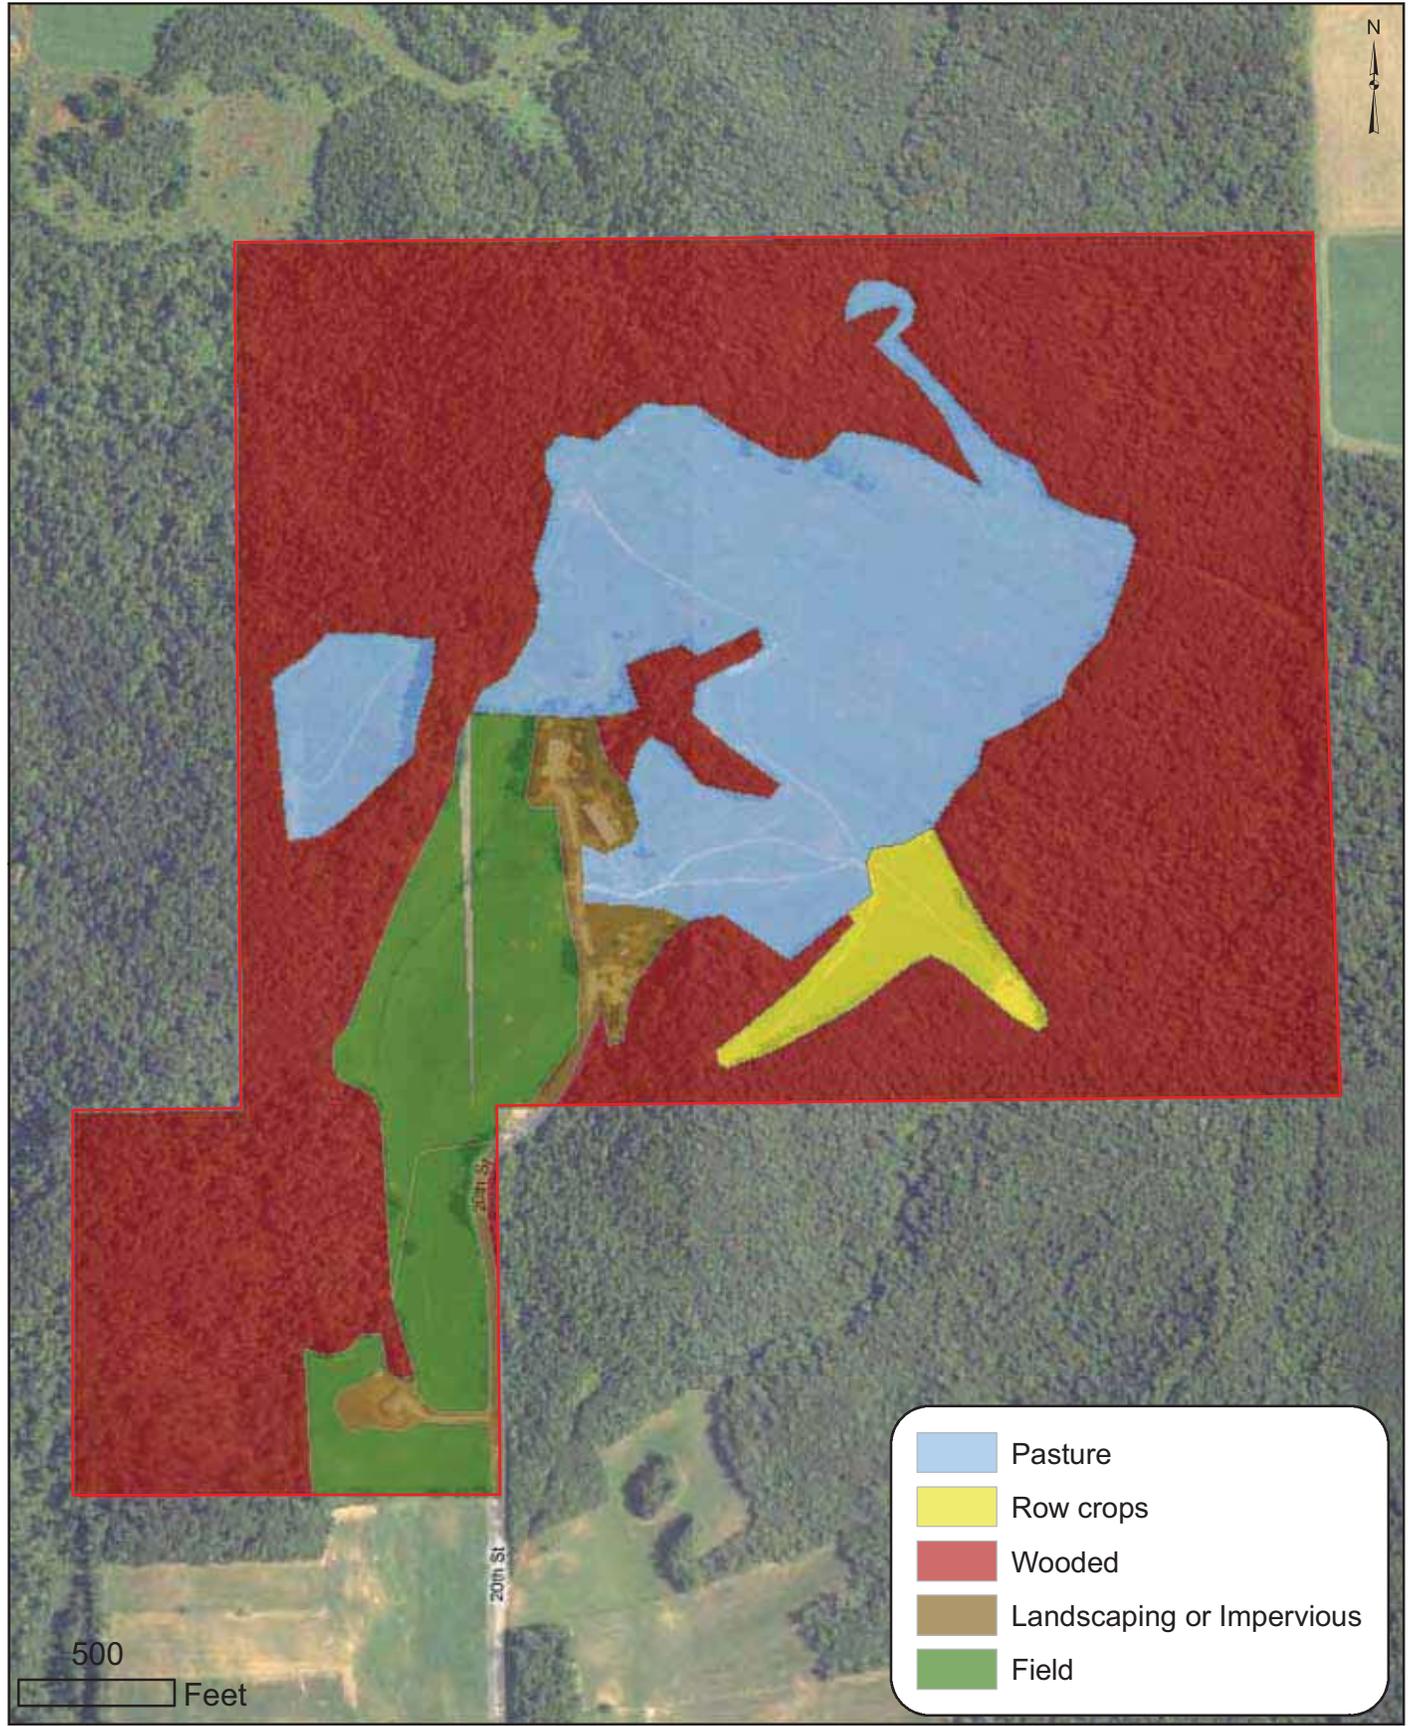
Figure
 4

Land Cover
 Schindler Property
 Cooks Valley, Wisconsin

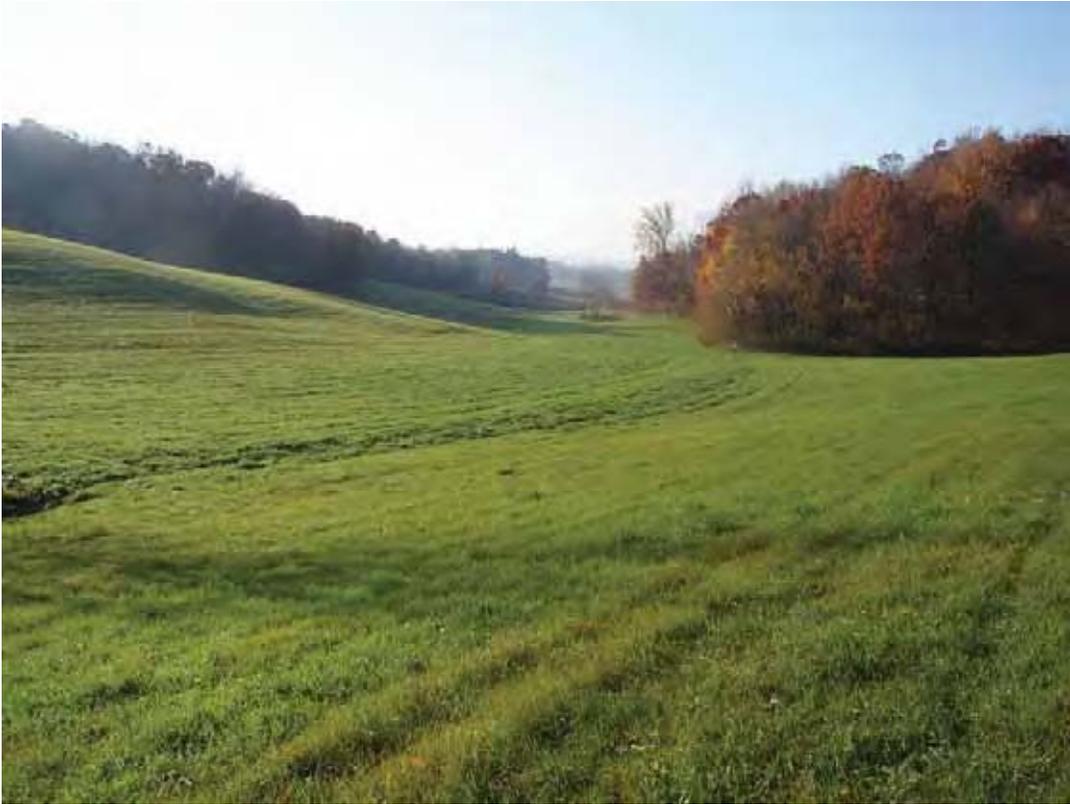
The vegetation in the bottom of the valley is the same as the sidelopes, and is dominated by orchard grass (*Dactylis glomerata* -FACU). This is a facultative upland plant, as are the associate species including common dandelion (*Taraxicum officinale* FACU), common plantain (*Plantago major* FAC), cocklebur (*Artium minus* UPL), white clover (*Trifolium repens* FACU), and red clover (*Trifolium pratense* FACU). This area is also dominated by dark olive brown (2.5Y 3/3)

No hydrology indicators were observed through the center of the property, with the exception of the secondary indicator of drainage pattern. Drainage pattern is an acceptable indicator, as it is clear that water flows through this portion of the property. When asked how the area responds during precipitation, Mr. Schindler indicated that during a good rain they would get flow through the site within hours. Once the rain stopped, the flow would also be gone within a few hours, even during multi-inch rainfalls. Based on these observations, I concluded that valley bottom does convey flow during rain events, and warrants designation as a waterway. It lacks wetland hydrology, hydric soils, and hydrophytic vegetation, however, and therefore cannot be considered to be wetland.

View of valley bottom from north to south

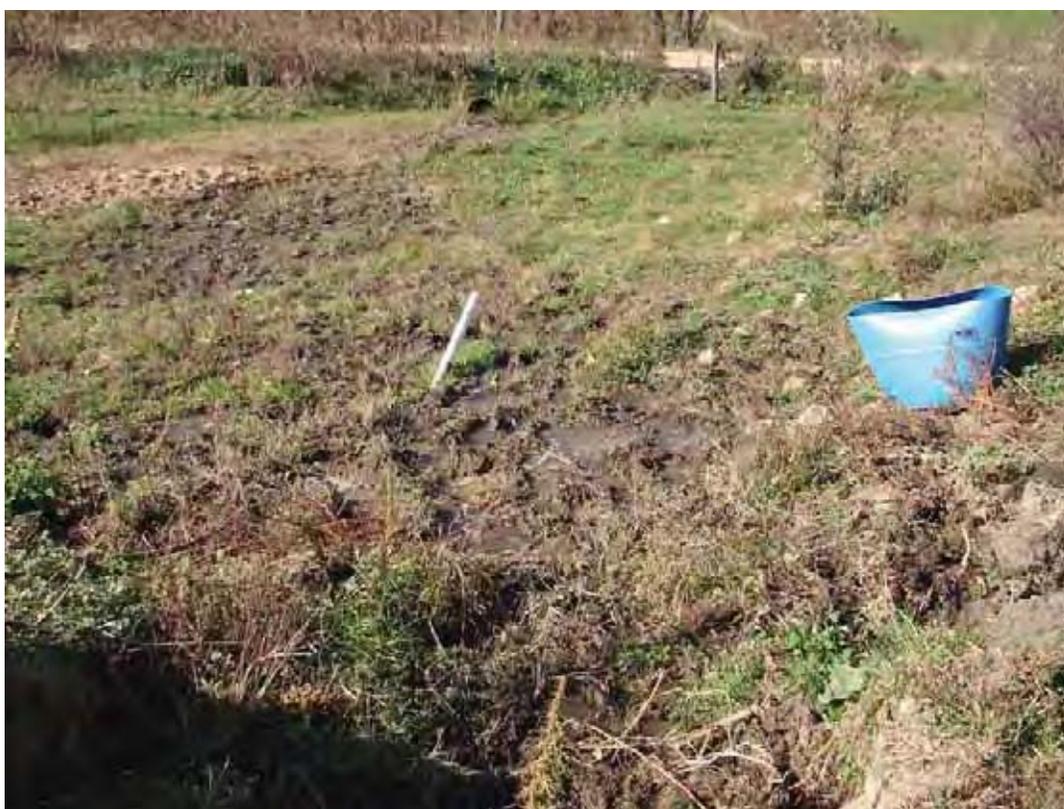
One area of spring seepage was identified by Mr. Schindler. This area is located by the barn, and is visible from the entrance road. Mr. Schindler indicated that this area is usually dry, but it started to be wet about a month prior to the field investigation following back to back 4 to 5 inch rainfalls. This rainfall turned most of the valley into drainage, which quickly went away within a day or two of the rain stopping. The exception was this area, which has continued to weep since then.

This area was investigated to determine if it met wetland criteria. A datasheet was also completed, and is attached (Appendix A). The seepage is located within the cow pasture, and has been trampled and rutted making a muddy depression. There is an apparent origin to the flow, where there is a small cut in the landscape. There is a small discharge, which flows down slope and under the roadway. It emerges on the west side of the roadway in a small flat area, before it continues down slope for a short distance. The seepage area follows the same path as surface runoff, and erosion from the runoff apparent.

Seepage area near barn. View is west from barn.

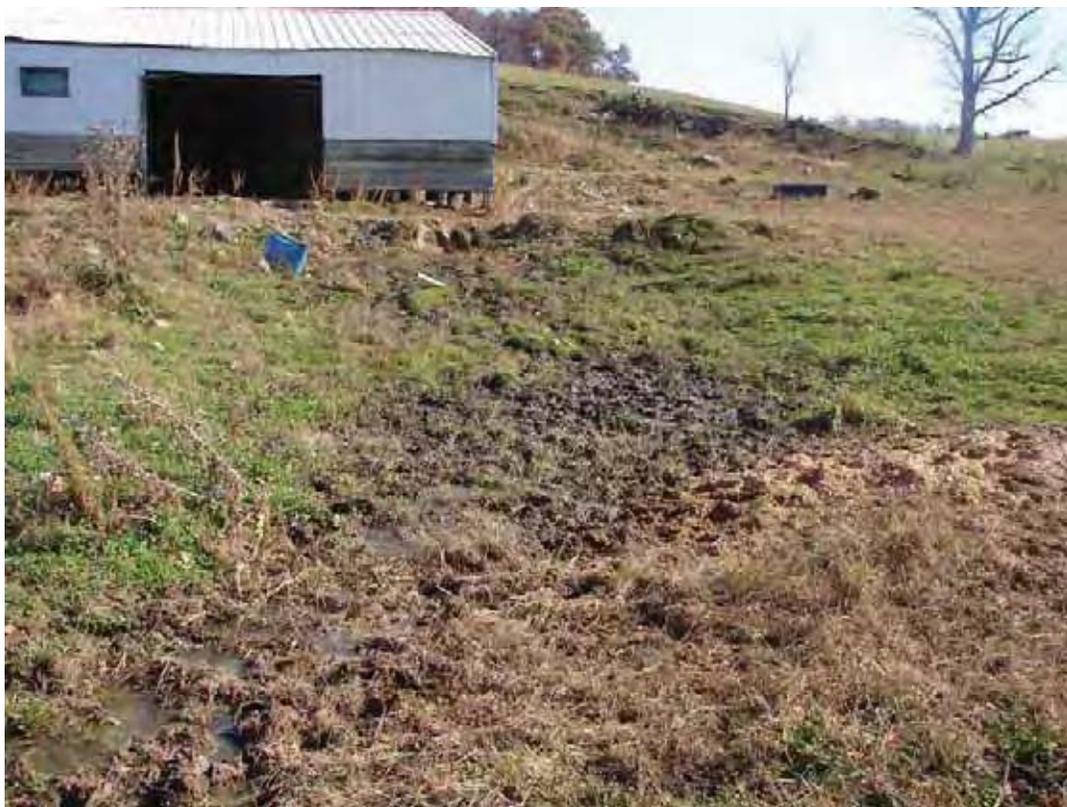
View of eastern seepage from the road to the barn

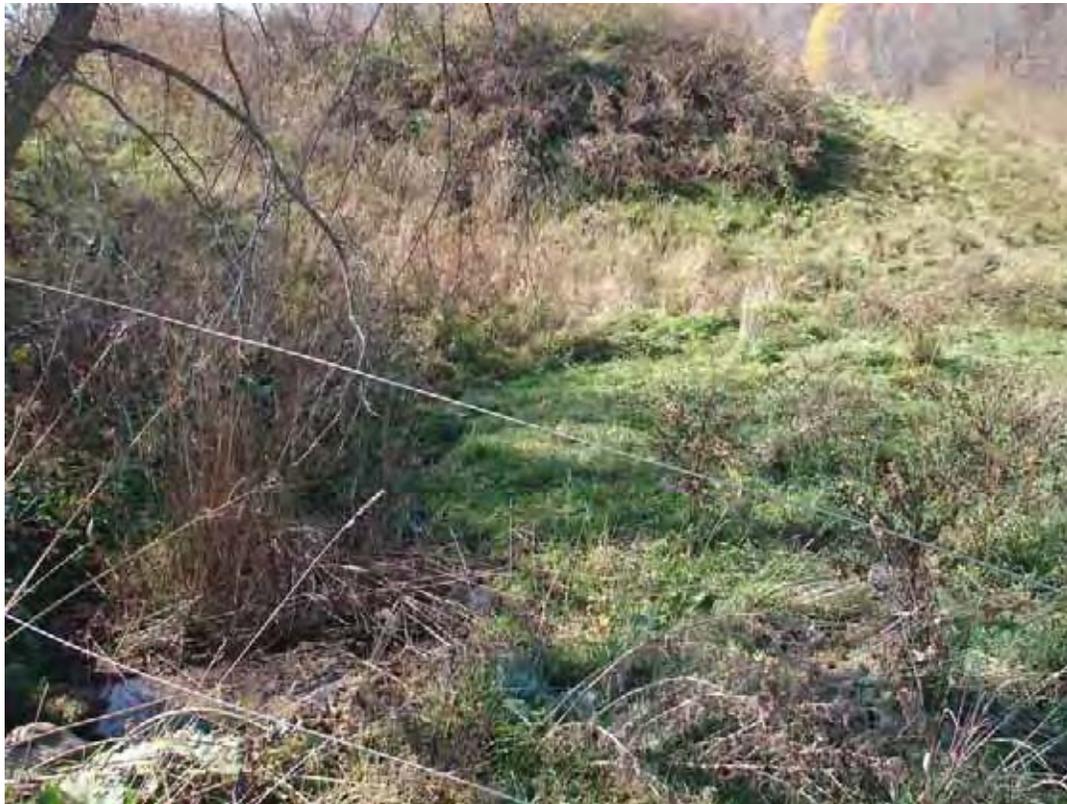
Seepage area on west side of the roadway, looking west.

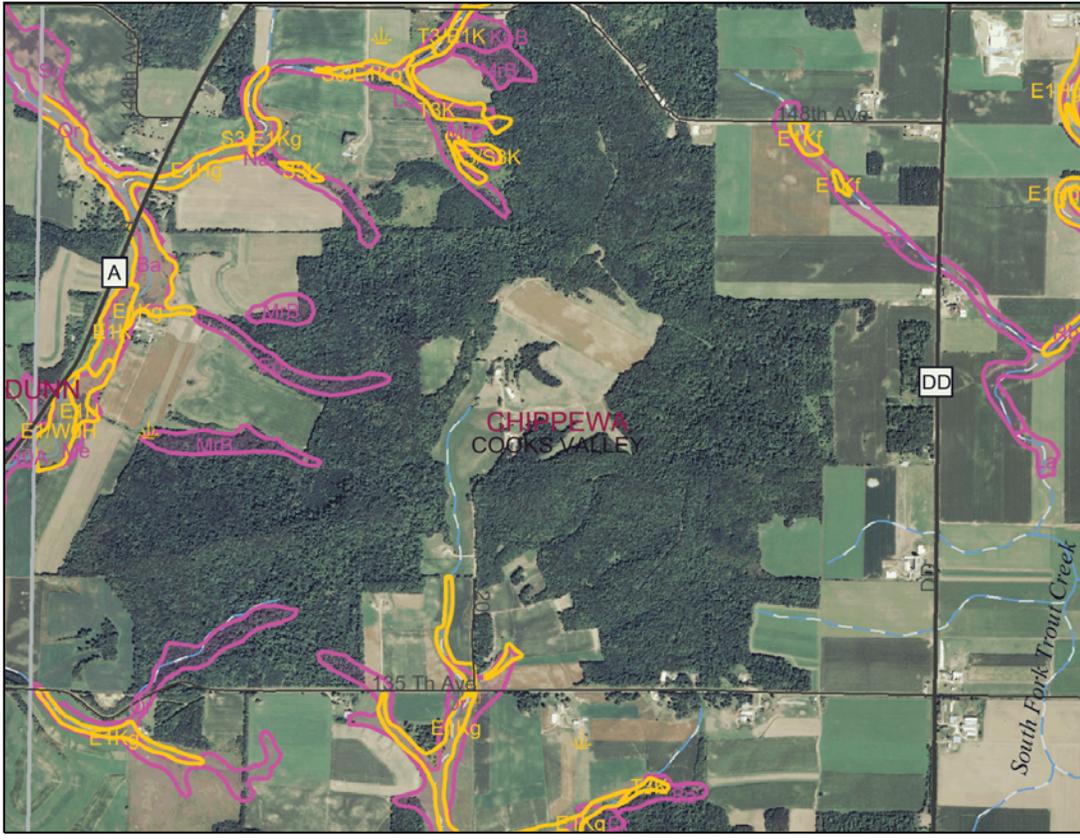
D. Schindler Property

The WWI considers a portion of the central drainage from 135th Avenue north to the property line to be wetland. This portion was not sampled as it is on private property, but it appears similar to what was observed further north. There is no debate that this intermittent stream does convey runoff out of the valley. The northern portion is very wide and has no channels. As the valley narrows, the location of the intermittent stream becomes more defined, and evolves into a grassed swale, most noticeably from the driveway south to the property line. This swale continues to lack hydrophytic vegetation, hydric soils, and hydrology, however, and cannot be considered to be wetland. The continued designation as an intermittent waterway from the property line south may be appropriate, as this is clearly the outlet for surface water runoff from the valley.

Wisconsin Wetland Inventory (WWI) maps show graphic representations of the type, size and location of wetlands in Wisconsin. These maps have been prepared from the analysis of high altitude imagery in conjunction with soil surveys, topographic maps, previous wetland inventories and field work. State statutes define a wetland as "an area where water is at, near or above the land surface long enough to be capable of supporting aquatic or hydrophytic vegetation and which has soils indicative of wet conditions." The principal focus of the WWI is to produce reconnaissance level information on the location, type, size of these habitats such that they are accurate at the nominal scale of the 1:24,000 (1 inch = 2000 feet) base map. The DNR recognizes the limitations of using remotely sensed information as the primary data source. They are to be used as a guide for planning purposes. There is no attempt, in either the design or products of this inventory, to define the limits of jurisdiction of any Federal, State, or local government or to establish the geographical scope of the regulatory programs of government agencies. Persons intending to engage in activities involving modifications within or adjacent to wetland areas should seek the advice of appropriate Federal, State, or local agencies concerning specified agency regulatory programs and jurisdictions that may affect such activities. The most accurate method of determining the legal extent of a wetland for federal or state regulations is a field delineation of the wetland boundary by a professional trained in wetland delineation techniques.
